Project Jeam

The Village Green Owners' Association

1.1 PROJECT SUMMARY

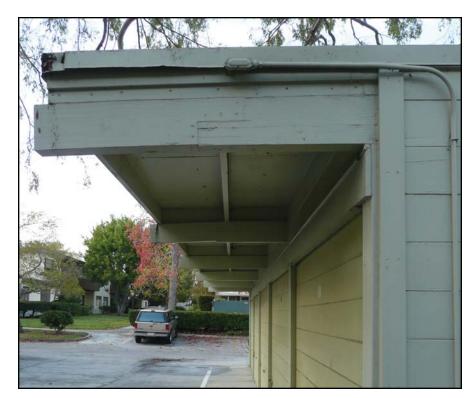
Many garage roof rafters have required previous repairs, as seen above.

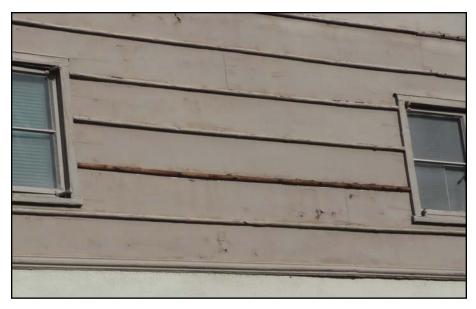
Exposure over time to light, wind, and water has resulted in weathered wood siding at Building 23.

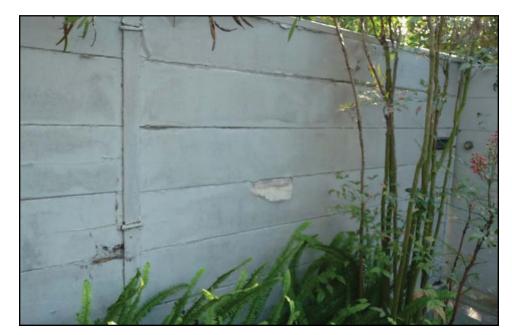
Warped and rotting wood patio dividers; this example is in worse condition than is typical at The Village Green.

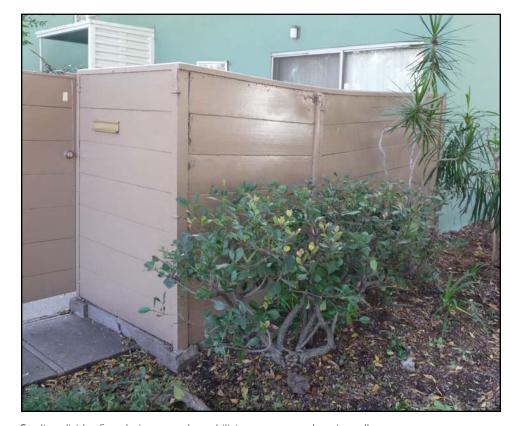
Settling divider foundations are de-stabilizing many wood patio walls.

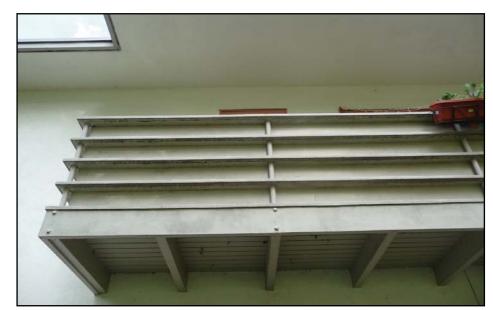
Plywood was used as siding at the interior faces of balconies at Type 3, 4, 5, and 8 buildings; as seen above at Building 82.

Plywood was and still is a mass-produced material that is widely available. The original plywood was painted, so any severely deteriorated sheets should be removed and replaced with new plywood cut to fit. Applying new sheets over original plywood is not recommended because it accelerates the deterioration of underlying plywood and decreases the visual integrity of the balcony design. In addition, thin veneer sheets are inappropriate because they do not reflect the original construction, are not as durable, and add unnecessary weight to the balcony structure. Any replacement sheets should be detailed to include a sealant joint at the ends. Maintaining a protective finish will extend the life of any newly installed plywood.

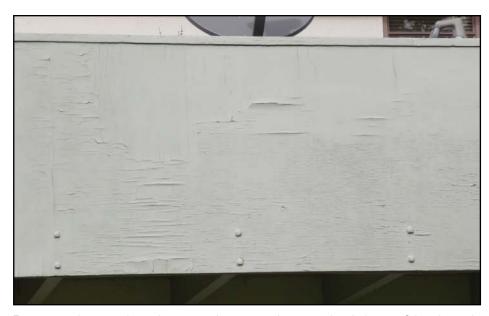
Extensive splitting and weathering can be seen in this more detailed view of the plywood conditions at Building 66.

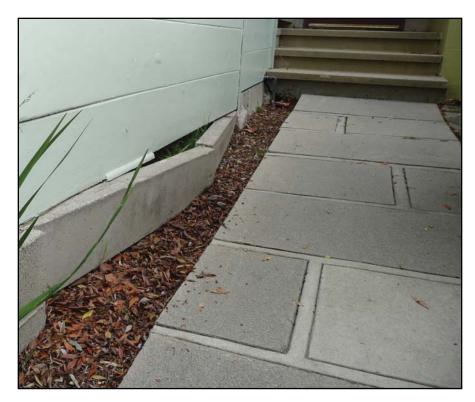
The historic concrete paving pattern loosely resembles stone paving; a section at the lower right of the photo has been replaced. Concrete conditions are typically poor at patio foundations, as seen above.

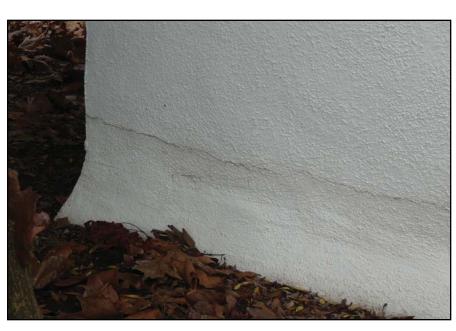
At residential buildings, stucco covers the joint between the foundation and the wall framing; small cracks in the stucco, likely from differential movement or seismic activity, are likely at this location.

After an appropriate stucco patching mixture has been determined, cracks should be routed out or spalled areas squared off. Square edges create good bond strength, and undercutting or dovetailing will give the new stucco an even better substrate to adhere to. The stucco patch should be applied, scraped level with the surrounding plaster, and left to cure. The patched area can be painted after it has cured completely.

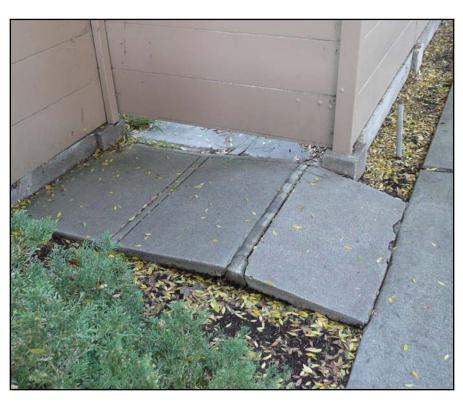
Concrete paving conditions are generally fair, deficiencies are limited to cracking and areas of displacement, as seen above.

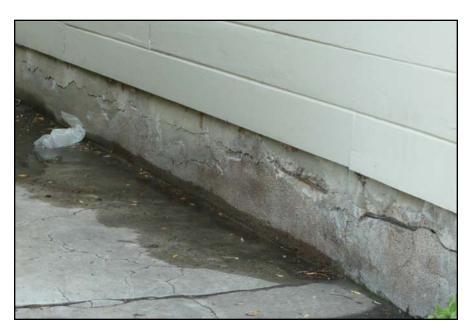
Garage foundations are in fair to poor condition; cracking and exposed rebar, as seen above, are typical.

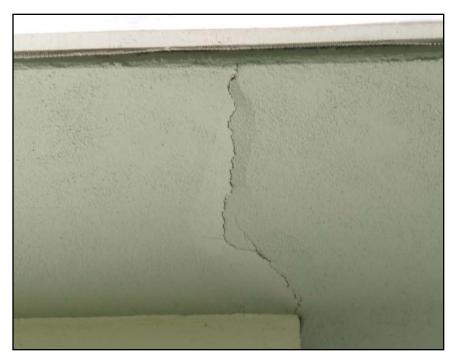
Cracks in plaster typically occur as a result of building movement or settling, and at the interface of dissimilar materials such as metal and wood which have different rates of thermal expansion and contraction. Plaster is a porous masonry material, and is therefore susceptible to damage from moisture entering from cracks, paint failure, or leaks within the wall, as well as prolonged wetting on the plaster surface. Water moving through plaster mobilizes soluble salts that are found in Portland cement; when the salts dry and crystallize, the resulting pressure causes material failure. Moisture can also cause corrosion or decay in the underlying wood framing and metal lath system, and the resulting expansion of the metal can lead to cracking and spalling of plaster.

Stucco cracking at soffits is common, as seen above at Building 92.

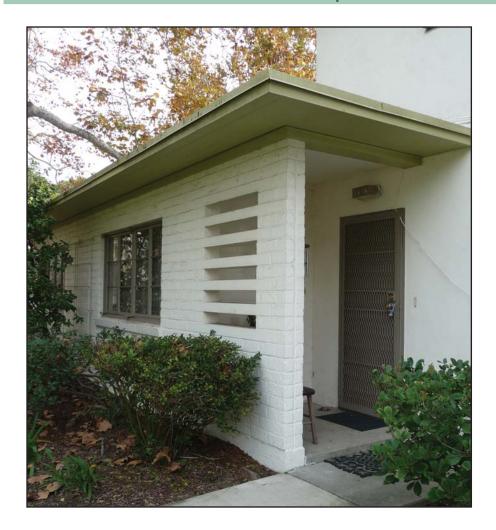
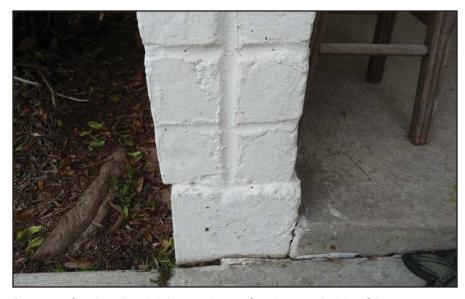
A section of brick wall is slightly turned on its foundation at Building 36, as seen in the above two images.

Typically, repairs to brick patio walls can be addressed during cyclic maintenance. Patio walls with only cracked bricks or mortar joints can be repaired and repointed. Cleaning will remove biological growth and efflorescence, and the parge coat at the top of the wall should be patched. However, a number of brick patio walls require immediate attention. It is recommended that any walls that lean significantly or have multiple large cracks be rebuilt entirely. The corroding metal plate should be removed from the design, and new walls built with better foundations.

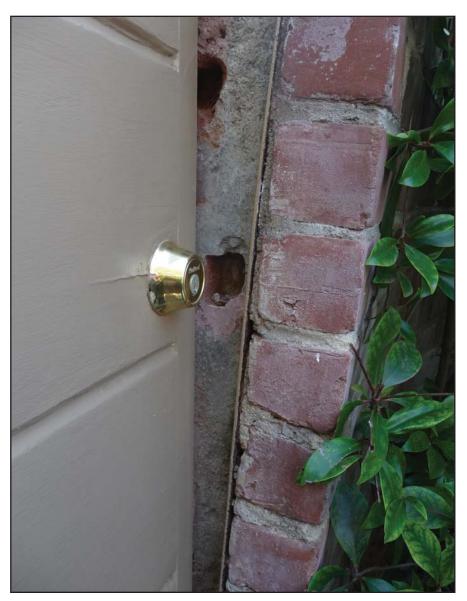
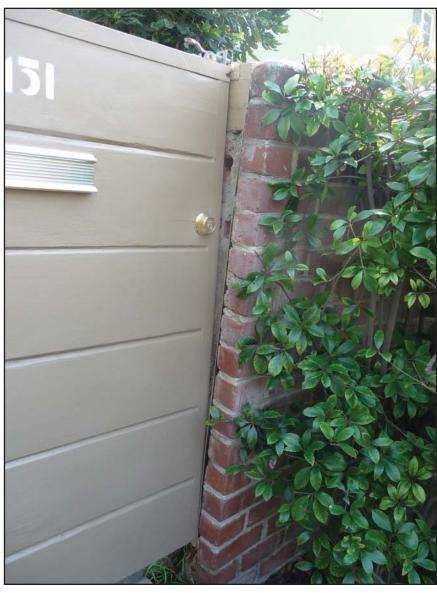
Many serpentine brick patio walls are in poor condition, in part due to poor design and detailing; a section of wall at Building 62, seen above, leans out significantly. At left, the metal plate embedded in the wall is visible.

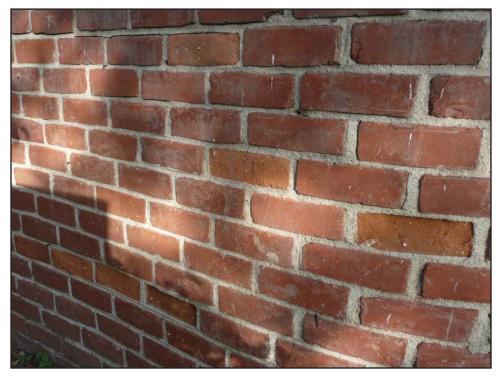
Eroded bricks, likely of inferior quality, can be seen at patio walls Building 43.

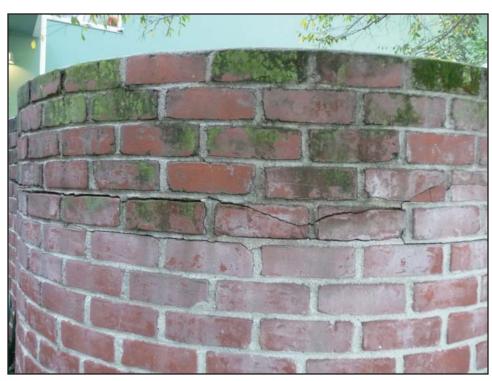
Biological growth and cracking through mortar joints and bricks, other typical brick patio wall conditions, can be seen above at Building 90.

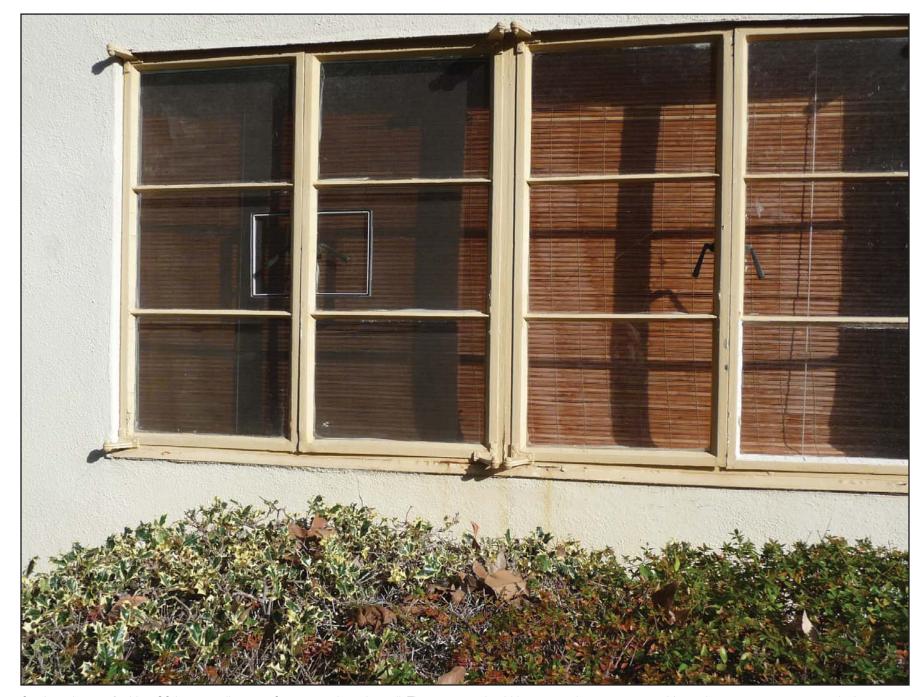
Steel windows at Building 32 have small areas of corrosion along their sill. The corrosion should be removed as soon as possible, and a new paint system applied.

Any visible corrosion at steel windows should be mechanically removed. Small areas of corrosion can be removed with a grinder with a wire brush attachment, or grit blasting may be more efficient if a large surface area is affected. The surface should then be wiped clean with a rag dampened in mineral spirits, and the exposed metal treated with an appropriate primer and paint system. With good routine maintenance, steel windows will last indefinitely.

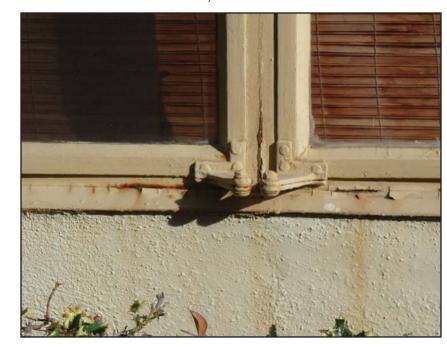
Cracking and peeling paint can be seen around the areas of corrosion at steel windows on Building 32.

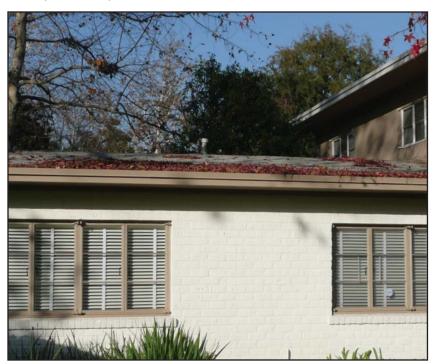
Debris that accumulates on roofs is typical, and should be removed periodically.
