# MANAGER REPORT

## SEWERS 2011

The VGOA is responsible for approximately 4.3 miles of sewer lines.

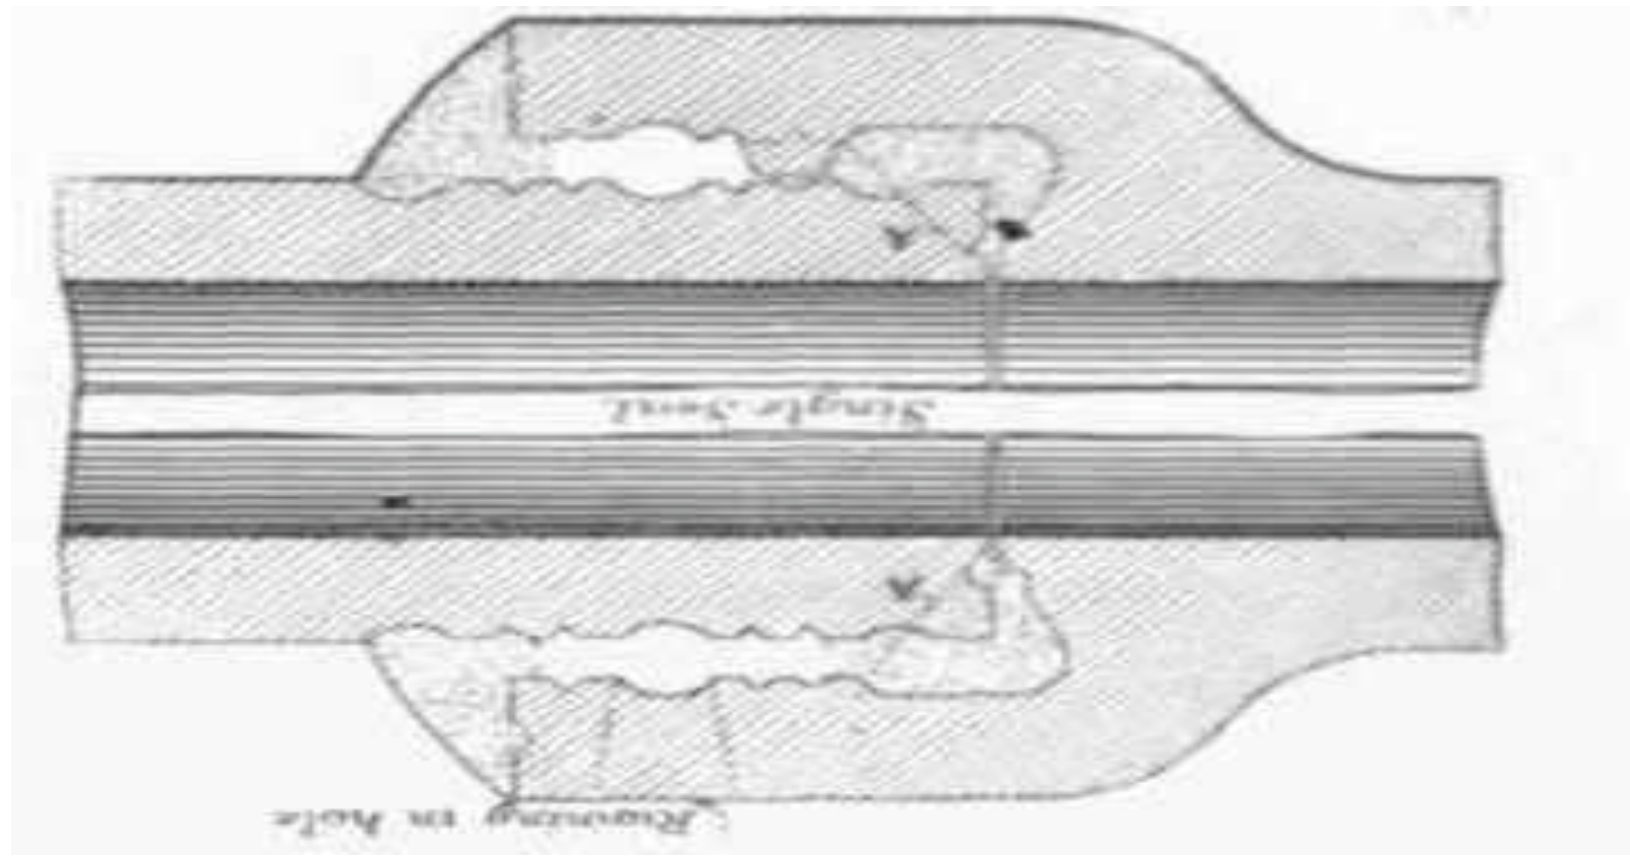
Old Clay connections become loose due to vibrations, settling and earthquakes.

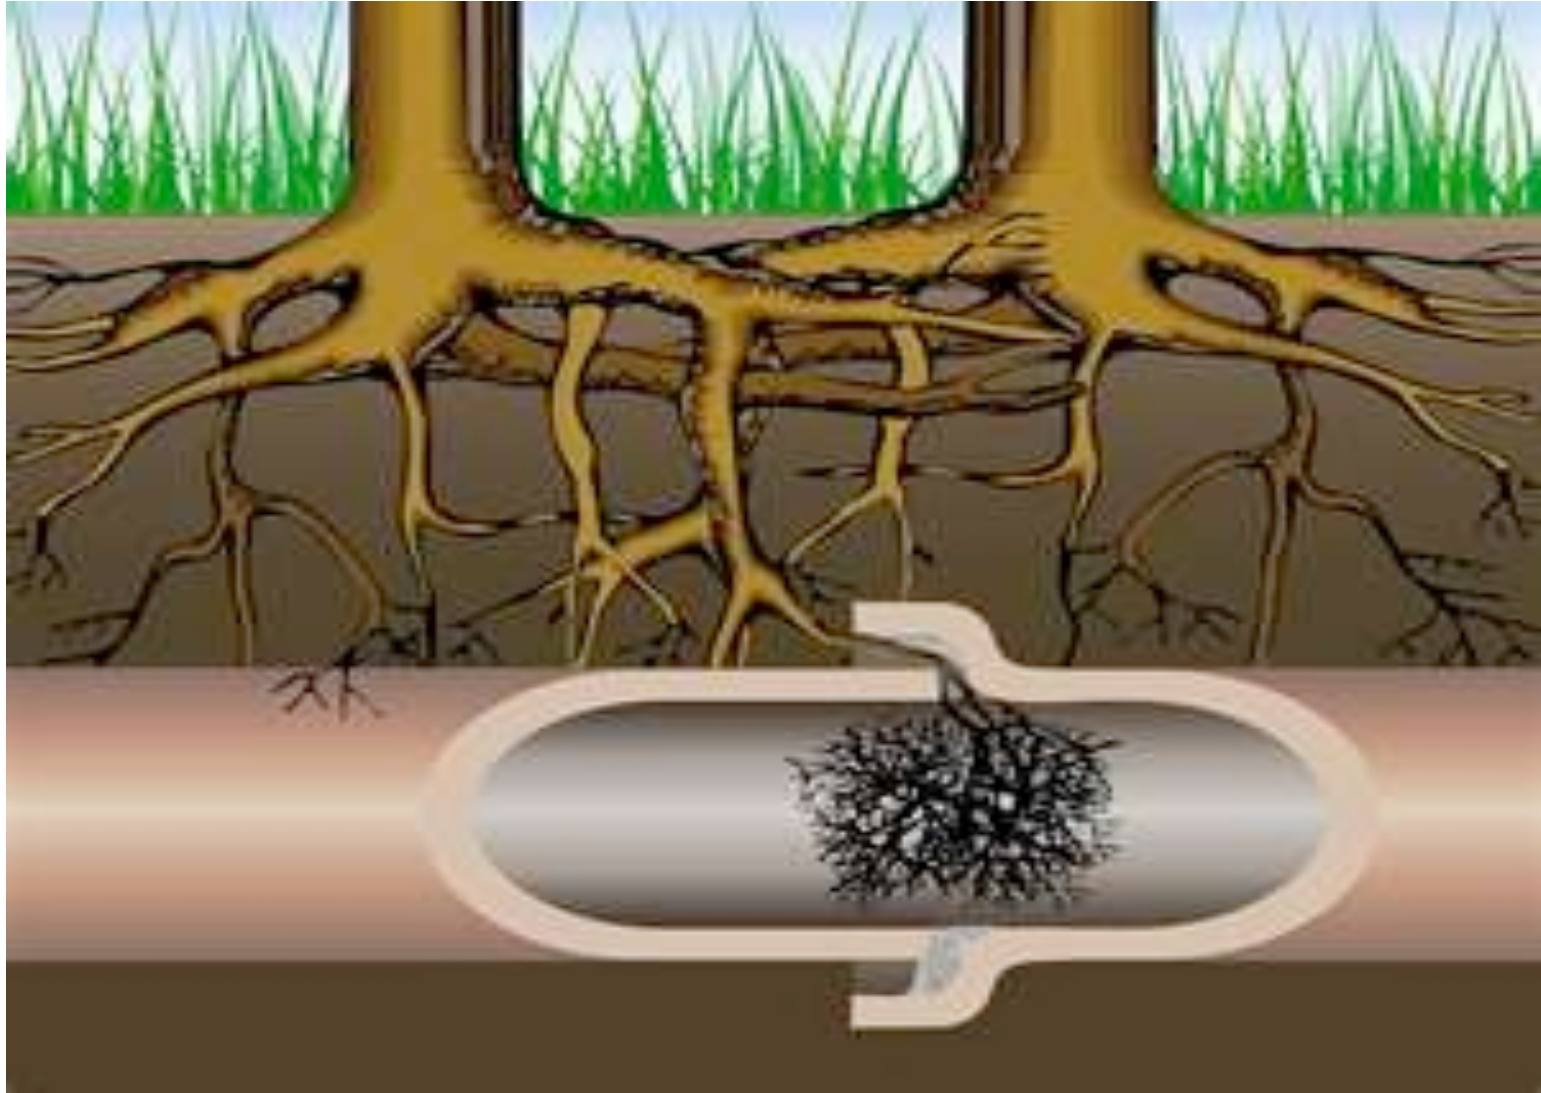
Roots find their way into the smallest cracks in pipes; once in, they grow very rapidly and clog the pipes.

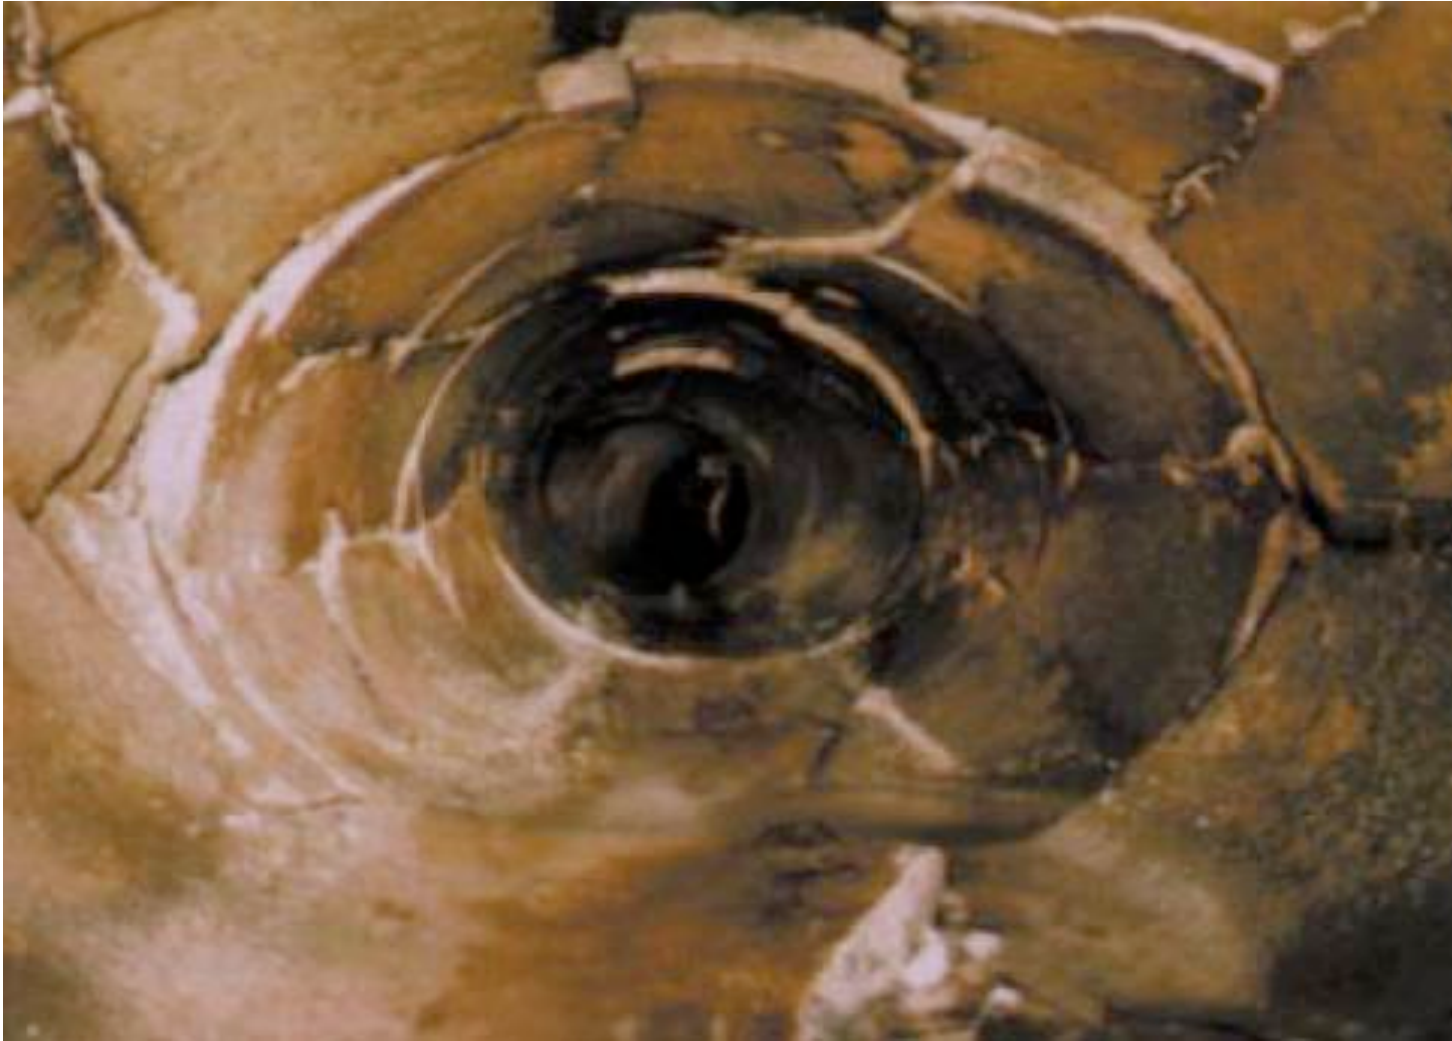
Photo of interior of typical VGOA clay pipe which has been cleaned. Note the number of cracks.

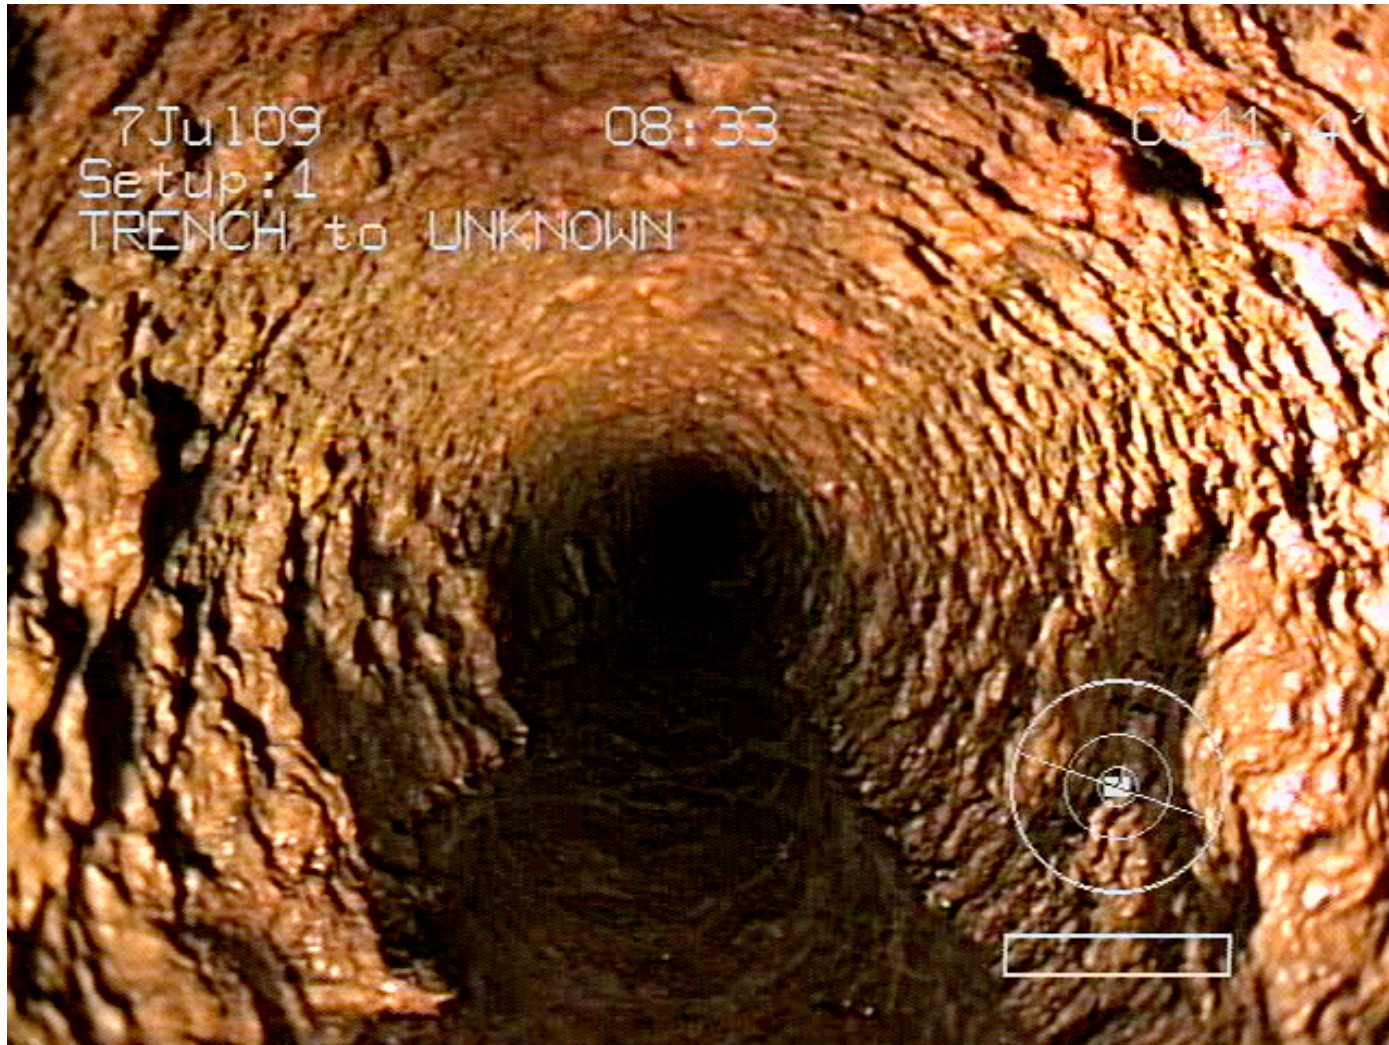
**Photo of the interior of a typical VGOA worn Iron pipe after it has been cleaned. In some areas more than 60% of the pipe is worn away.**

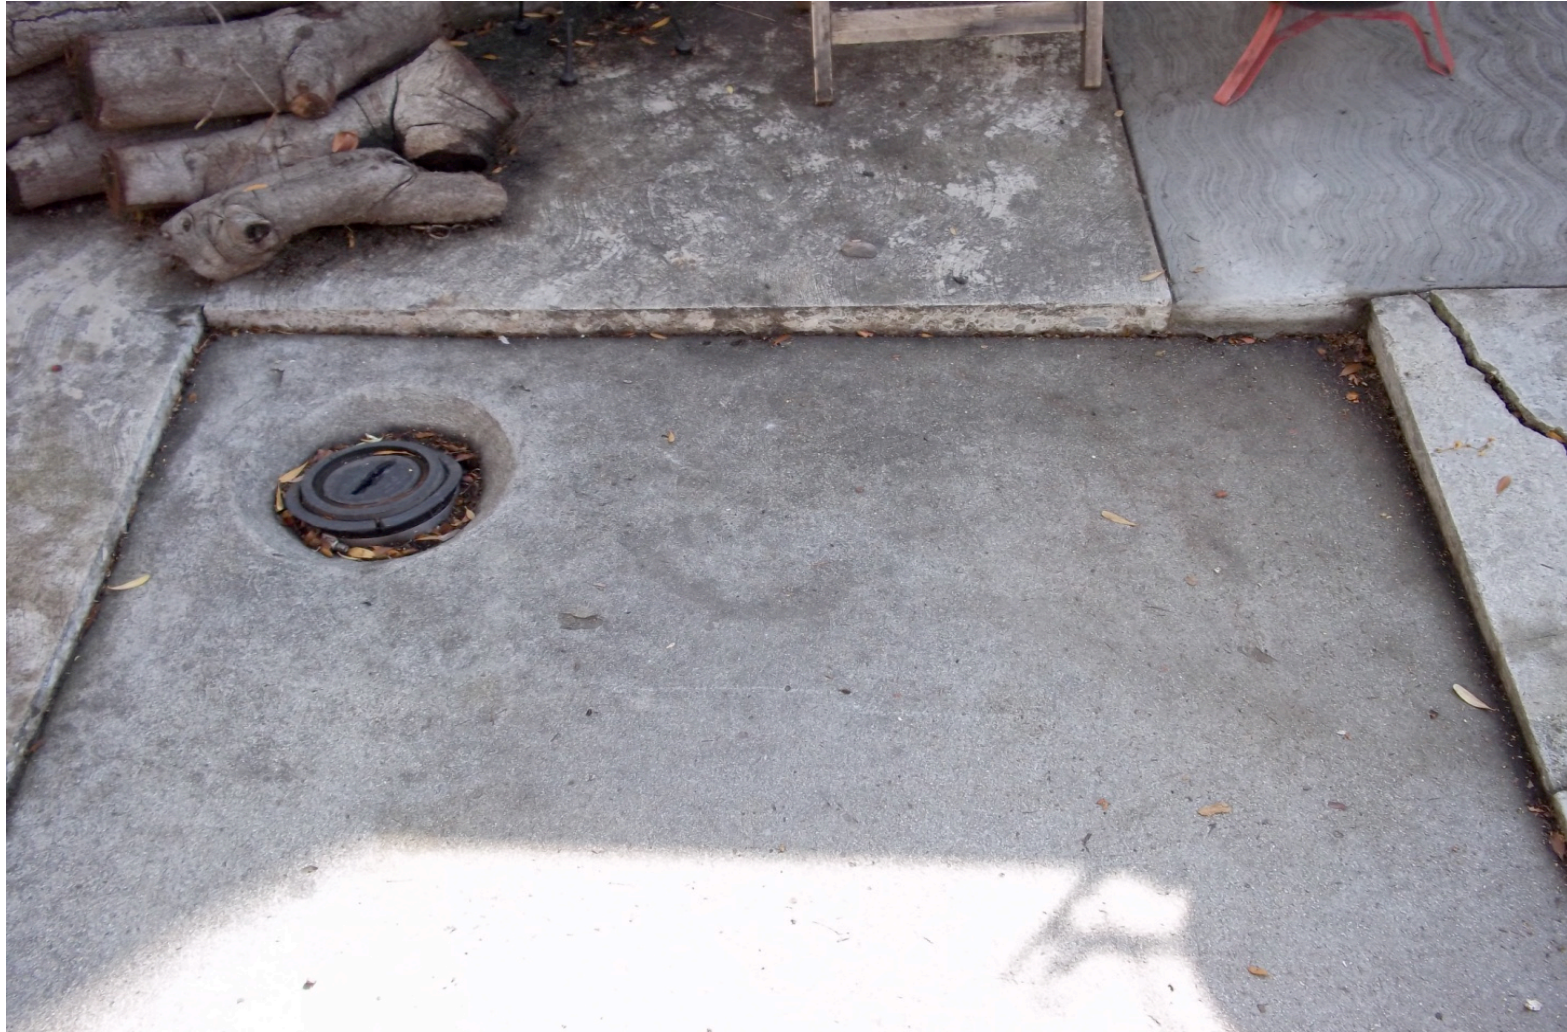
**Improper backfilling will result in unstable soil conditions which will allow for sinking patios, fences, and perhaps buildings. It costs more to repair than to do properly the first time!**

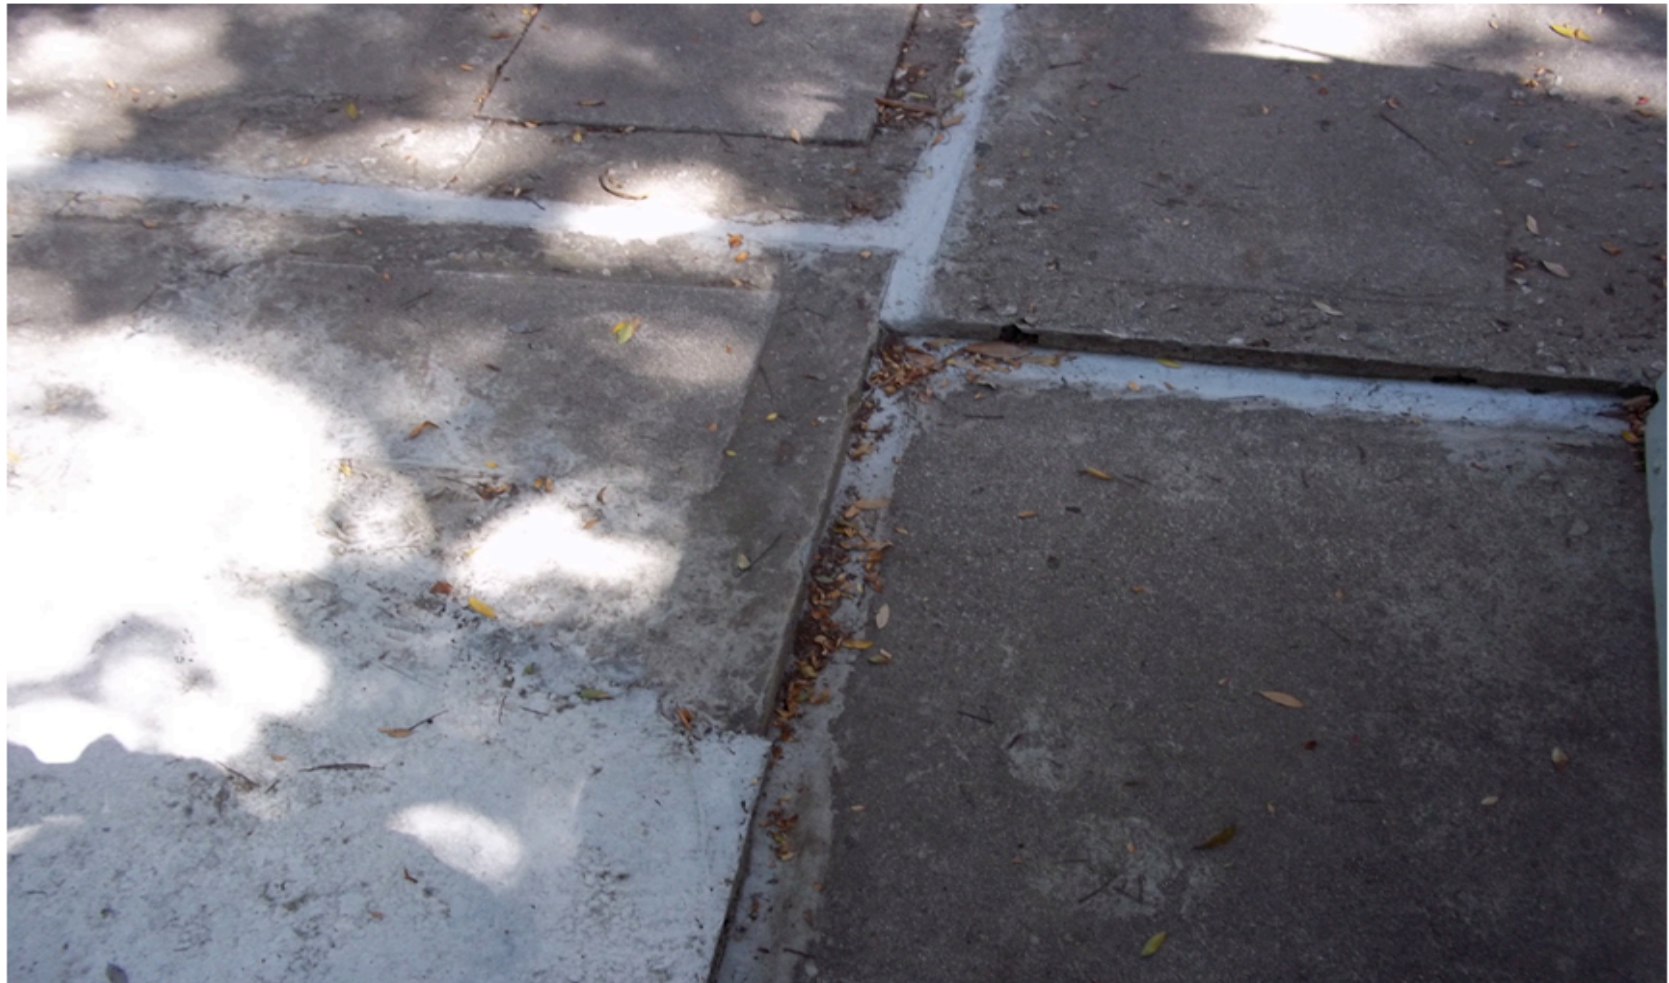
**The work was done without proper techniques. Note the settling (sinking) of the paver in this photo.**

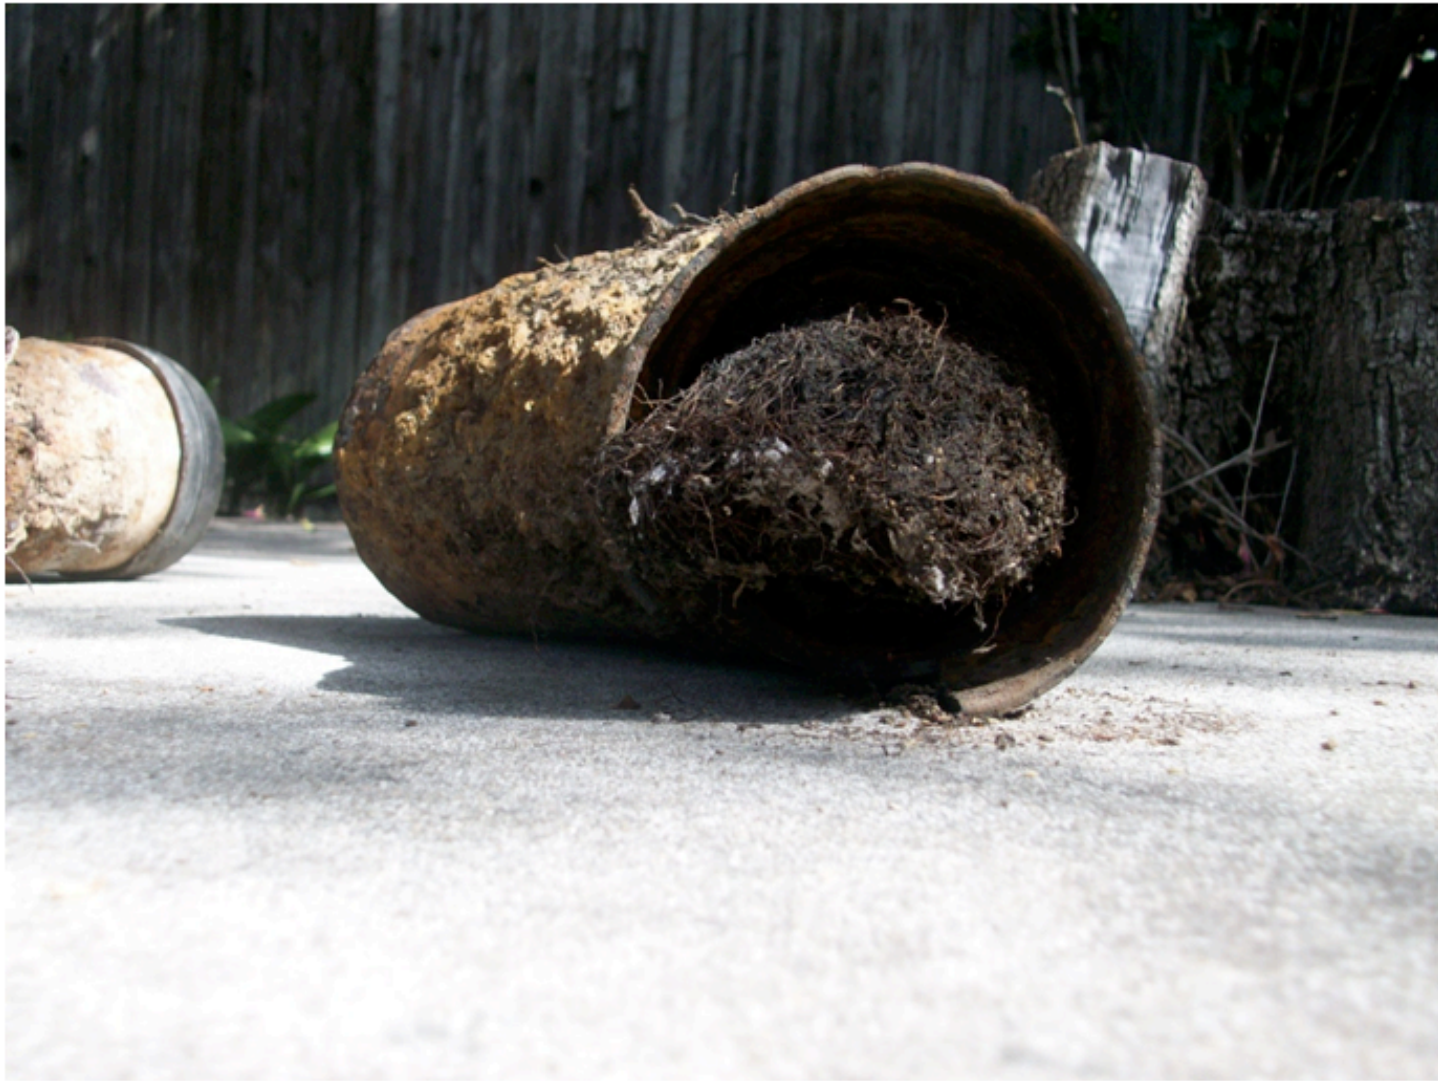
During replacement we found approximately  $\frac{1}{2}$  of all VGOA 4" lateral lines clogged.

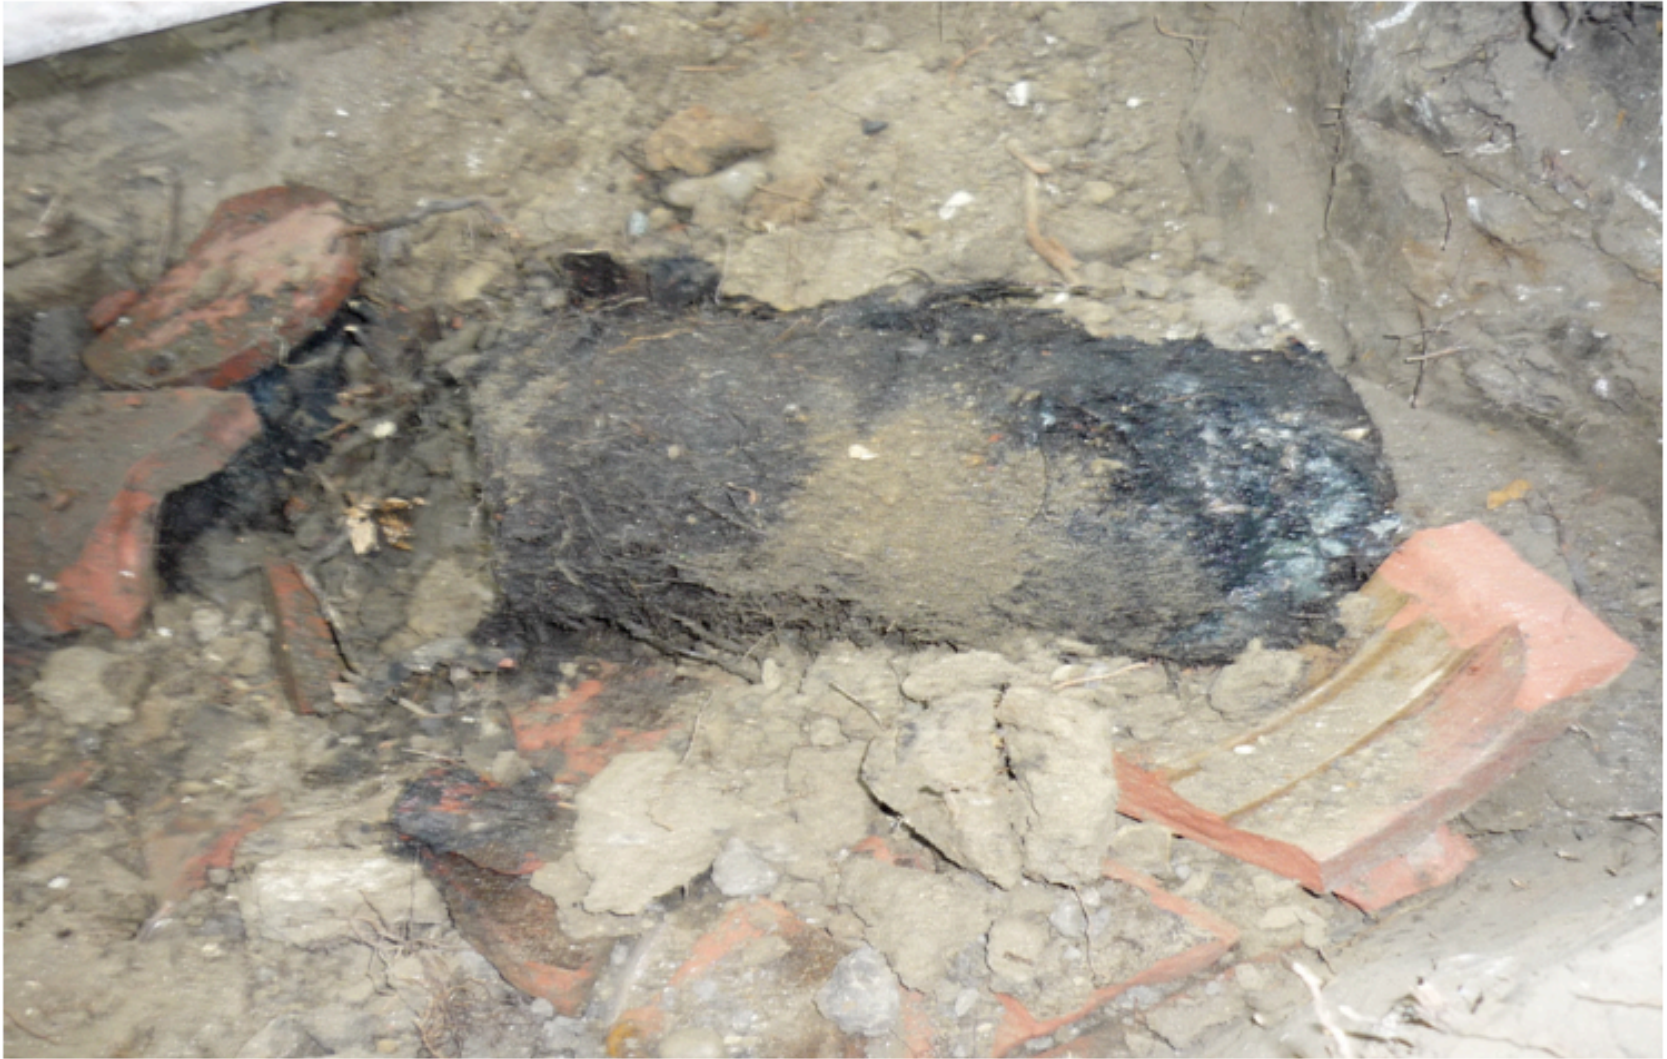
**During the 2011 repairs, varying degrees of root-damage/blockage/broken-pipes to approximately ½ of all Lateral connections (45) was discovered.**

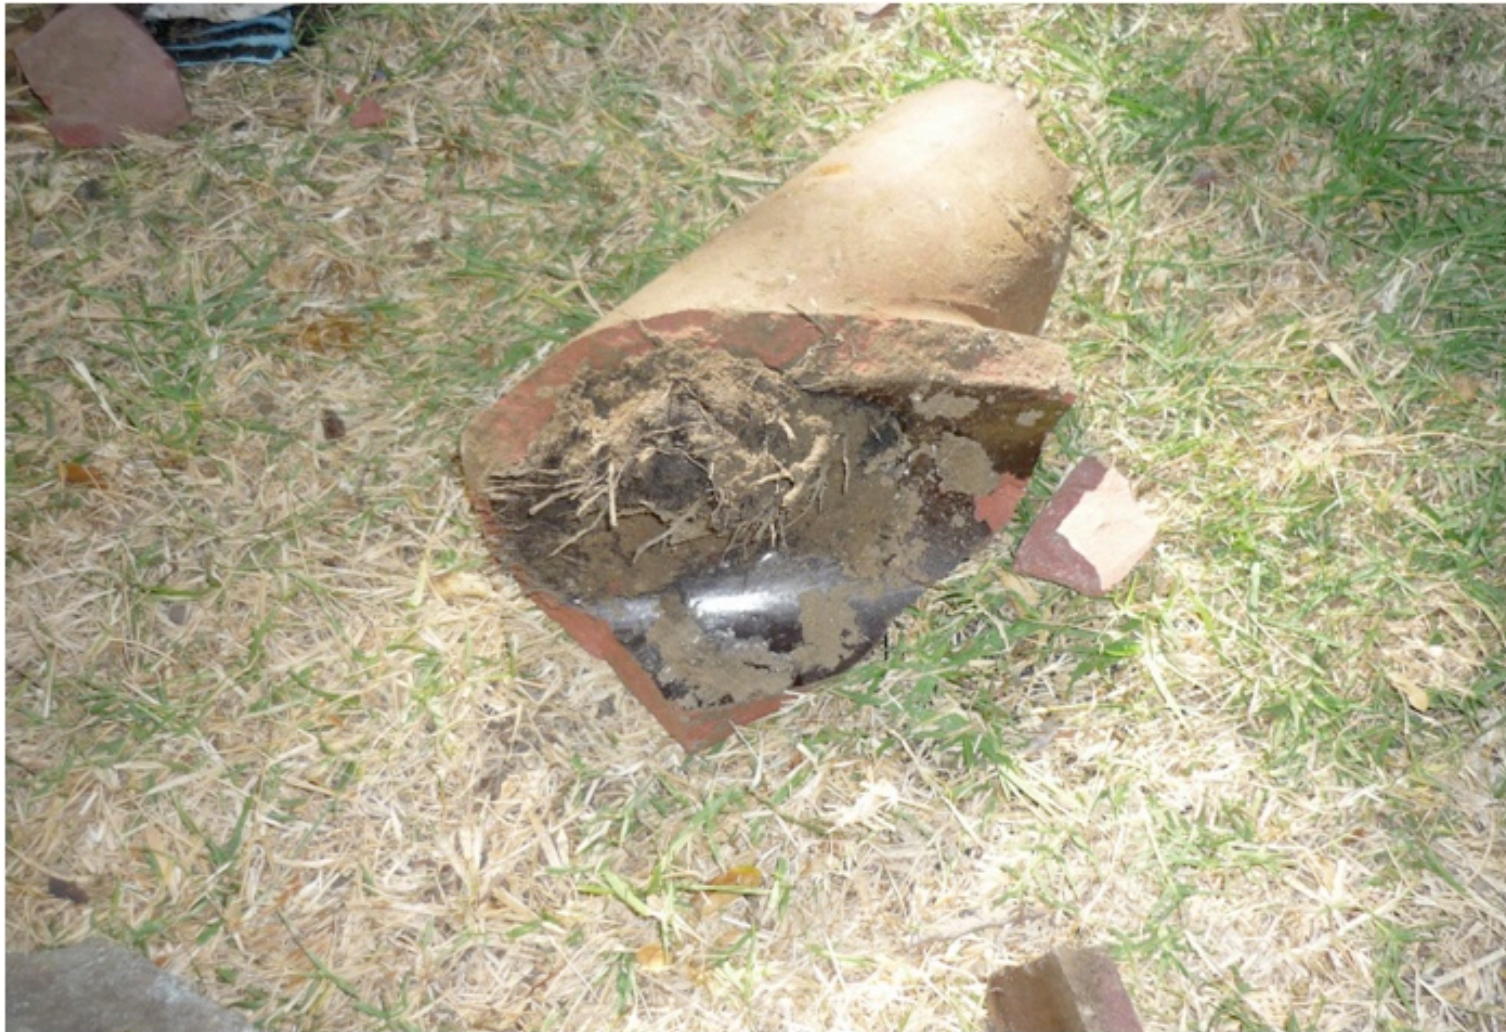
**In some locations roots had completely blocked and/or destroyed elements of the sewer lines.**

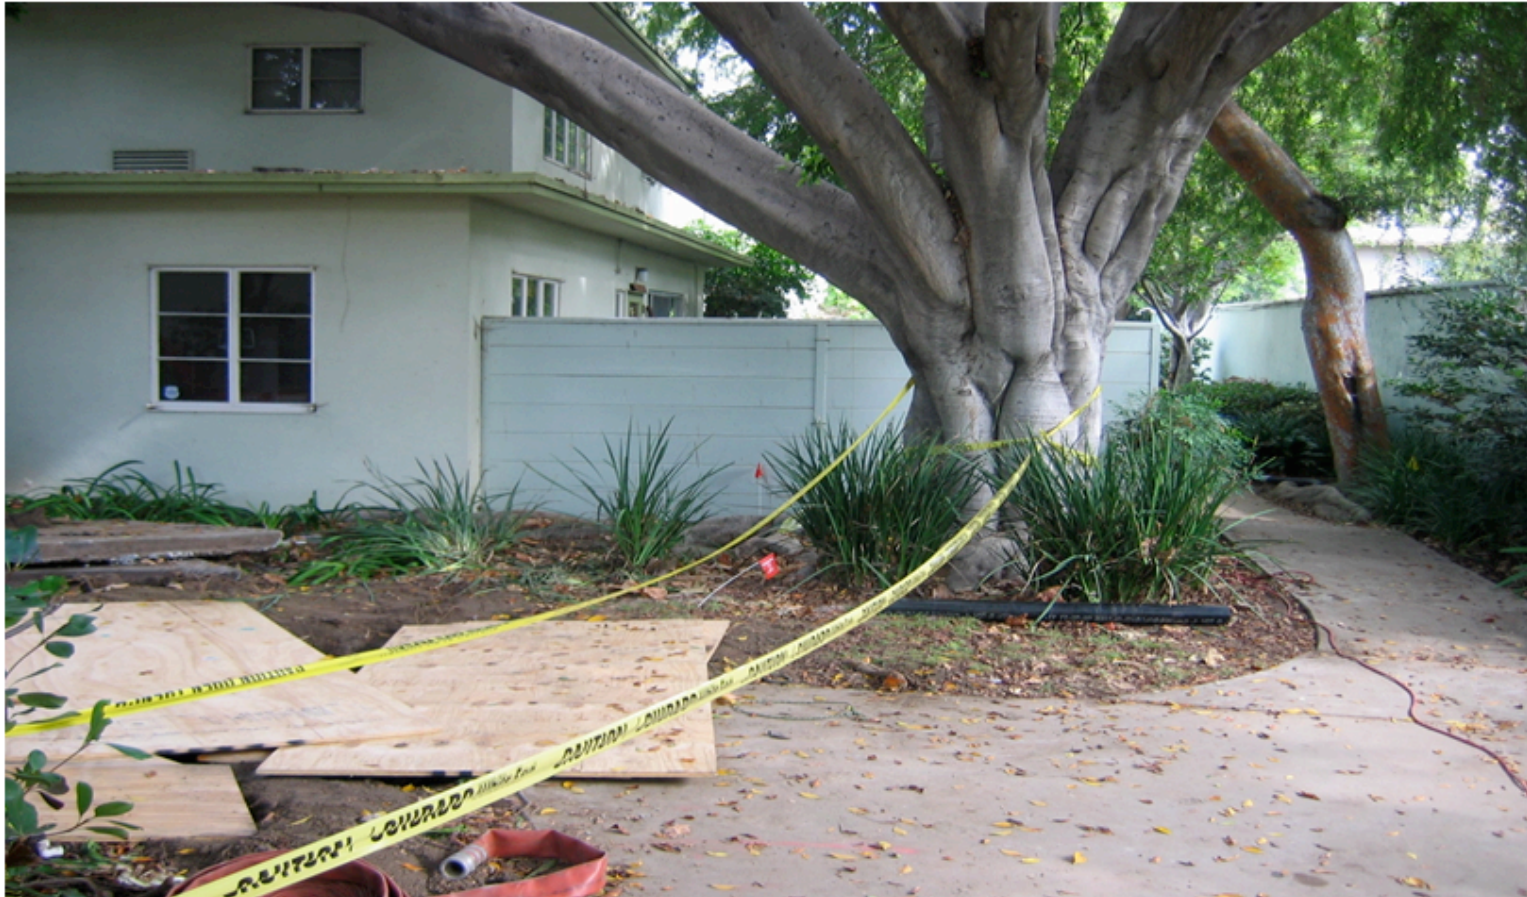
30+ feet of the 6" main sewer line running between buildings 31 & 32 was completely gone.

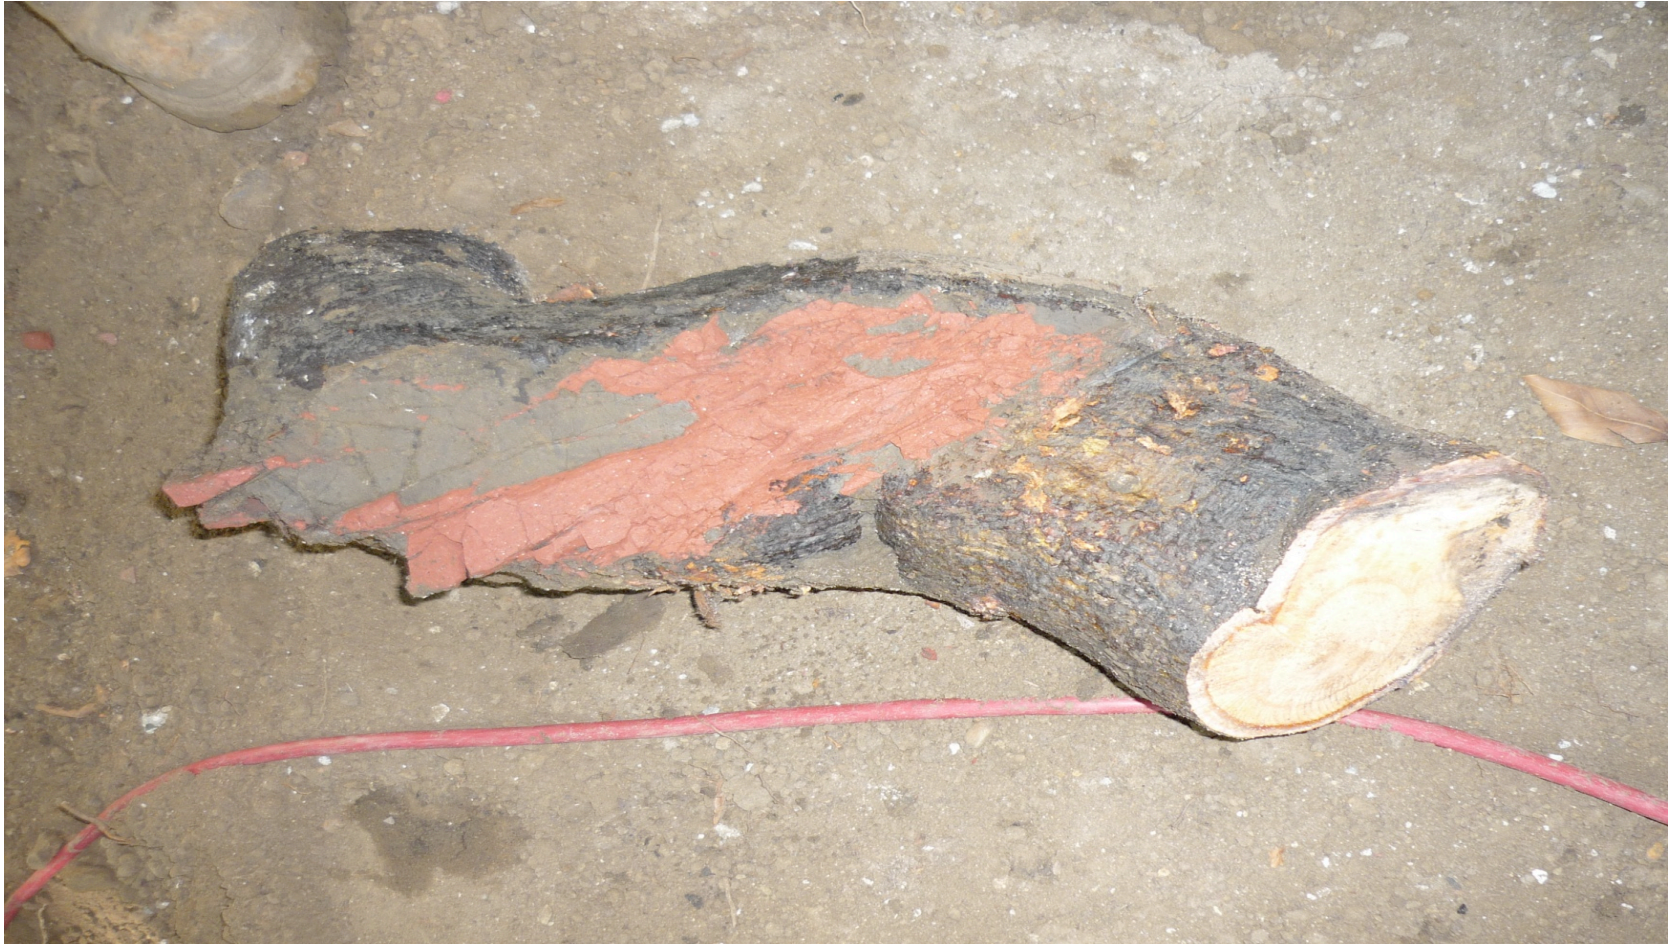
**Upon excavation it was revealed that the sewer pipe between Buildings 31 & 32 had been overcome by tree roots.**

**You can see the tree root has actually absorbed the sewer line.**
