Project Jeam

The Village Green Owners' Association

1.1 PROJECT SUMMARY

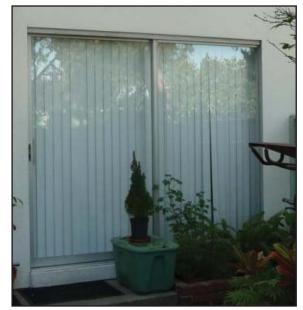
Aluminum frame sliding doors replaced many door and window configurations at patios after the 1963 flood. In more recent years, vinyl frame sliding and wood French doors have also been used. Replacement sliding doors are also seen at balconies and the one-story ends (park elevation) of Type 7 buildings.

Non-historic: an aluminum frame sliding door at the Non-historic: partial view of a vinyl frame sliding door patio

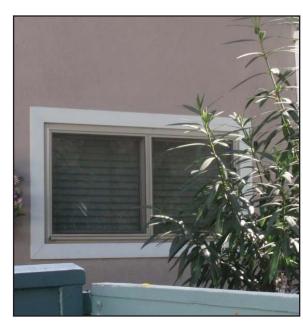
All windows were historically multilight steel casement and fixed windows. Some windows have been replaced with vinyl sliding windows, which is an incompatible replacement.

Non-historic: a new vinyl window with a vinyl surround

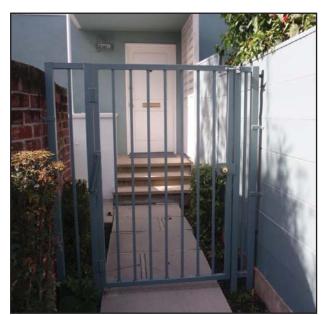
Examples of metal gates added at the front of the walkway leading to unit entries at the patio elevation

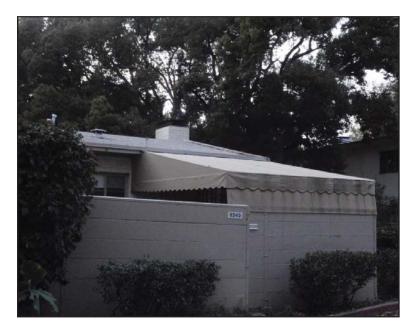
Canvas or metal awnings are common additions to patio doors, patio areas, or balconies. Supports vary but they are commonly metal rods. They are all considered non-historic, as awnings were not part of the original design.

A canvas awning over the patio area

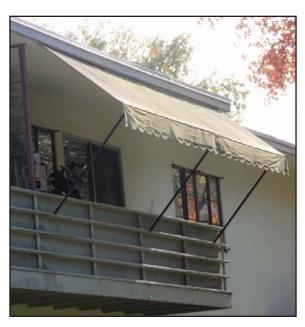
A canvas awning with metal support rods at a balcony

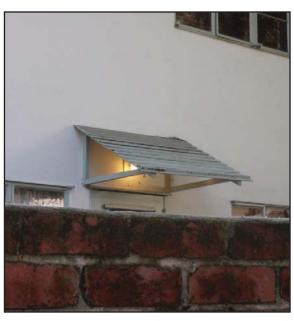
A metal awning over a patio door

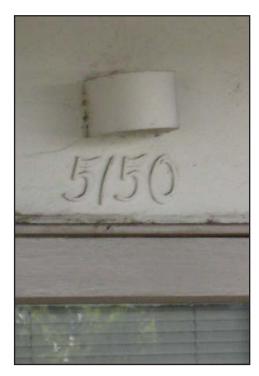
Historic: a simple, curved sheet metal shade over a light bulb (now painted).
Address numbers in photo are non-historic

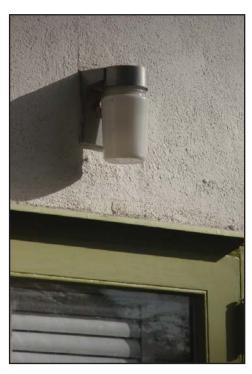
Compatible: cast aluminum and glass patio light (also seen in a dark bronze), likely installed during the condominium conversion

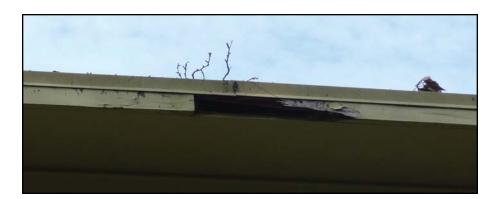
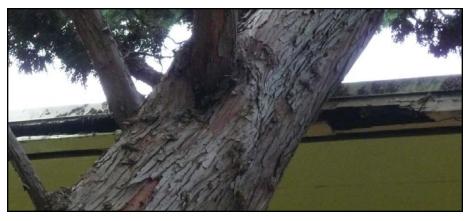
Multiple areas of rot and damage can be seen at wood fascia boards at Building 35 in the two photos above.

Rotted wood needs to be replaced because it lacks cohesion and structural strength, and fungal growths that cause it may spread under certain environmental conditions. Replacement strategies include selective patching repairs or replacing the entire component. Repair methods include plastic patches, where moldable fillers such as epoxy or putty are placed in voids, or Dutchman repairs where material loss is replaced with wood cut to size. Plastic repairs may be strengthened with non-corroding rods or plates inserted into larger elements such as posts or columns. Repair methodologies depend on the function of the wood component (e.g., structural elements vs. trim) and the extent of damage. If a wood component is to be repaired, all rotten material must be removed and the exposed surfaces treated with a fungicide/insecticide wood preservative. Both plastic patches and Dutchman repairs must fit tightly to the existing wood to prevent moisture intrusion and further rotting of the wood. Repairs and replacement components should match the profile, texture, and color of the historic fabric; ideally Dutchman repairs and replacement elements should be the same wood species as the material being repaired. At a site like The Village Green, where many mass-produced materials have been used, the replacement of whole pieces of wood elements may be more appropriate and cost effective than more specialized repairs. The exception to this is redwood, which may be prohibitively expensive or of lower quality than the original wood.

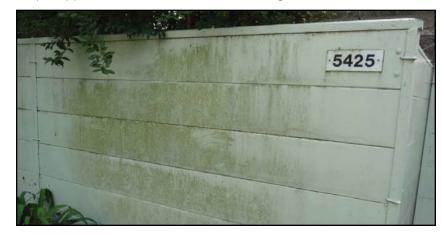
Biological growth at wood patio walls, as seen above, is indicative of damp conditions.

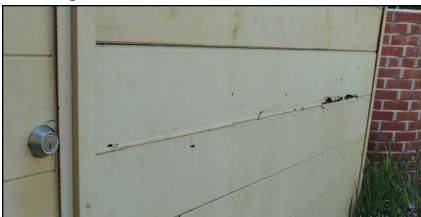
Another example of warped and rotting wood patio walls can be seen above; with the most visible damage located at the right side of the image.

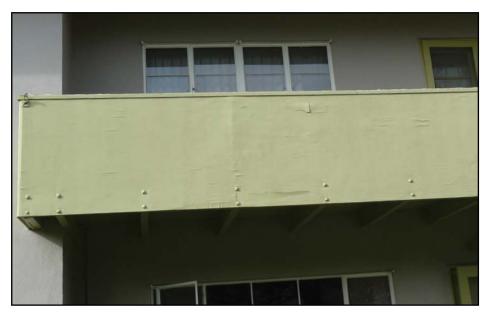
Plywood splitting and warping can also be seen at Building 28.

Plywood was and still is a mass-produced material that is widely available. The original plywood was painted, so any severely deteriorated sheets should be removed and replaced with new plywood cut to fit. Applying new sheets over original plywood is not recommended because it accelerates the deterioration of underlying plywood and decreases the visual integrity of the balcony design. In addition, thin veneer sheets are inappropriate because they do not reflect the original construction, are not as durable, and add unnecessary weight to the balcony structure. Any replacement sheets should be detailed to include a sealant joint at the ends. Maintaining a protective finish will extend the life of any newly installed plywood.

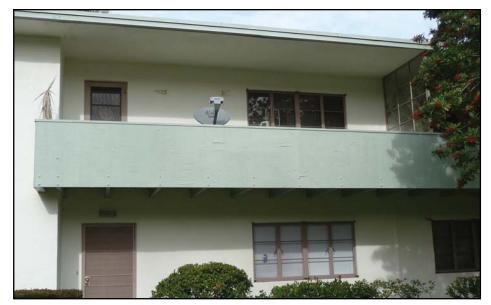
The layered structure of plywood makes it most vulnerable at its ends, where the separate layers are all exposed. The adhesives holding the wood veneers together may deteriorate with extended exposure to moisture, high temperatures, or ultraviolet light, depending on the type of adhesive used. Most plywood made in the 1930s and 40s was produced with synthetic resin adhesives. The plywood siding at The Village Green is particularly susceptible to deterioration due to its construction detailing; those vulnerable ends are exposed to light and moisture at the balcony corners.

Plywood is most vulnerable at its ends; at balconies the ends of each separate panel can often be seen lifting or warping slightly, such as above, at Building 66.

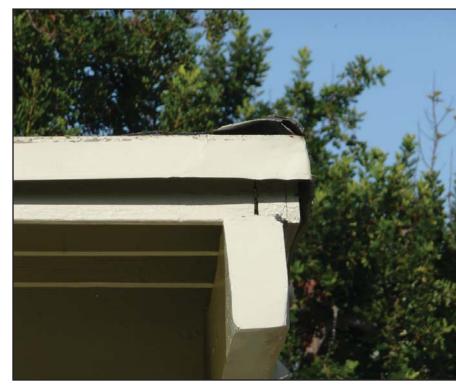
Roll roofing is vulnerable at its edges and ends; a section can be seen lifting at a garage end above.

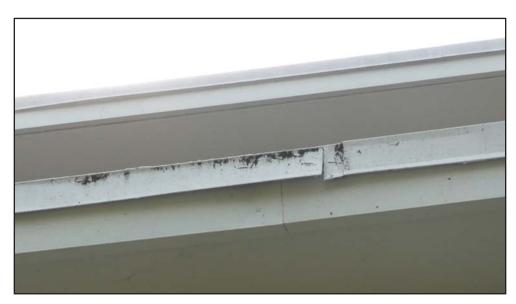
Sheet metal flashing is slightly bent and beginning to lift at Building 50.

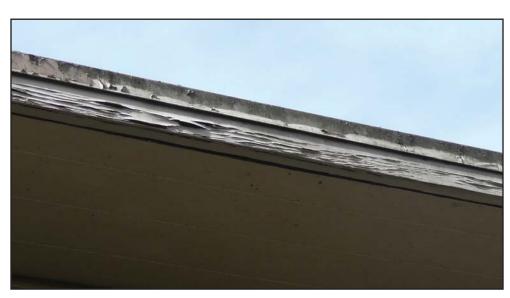
Maintaining a finish will extend the life of sheet metal flashing. The image above is from Building 23.

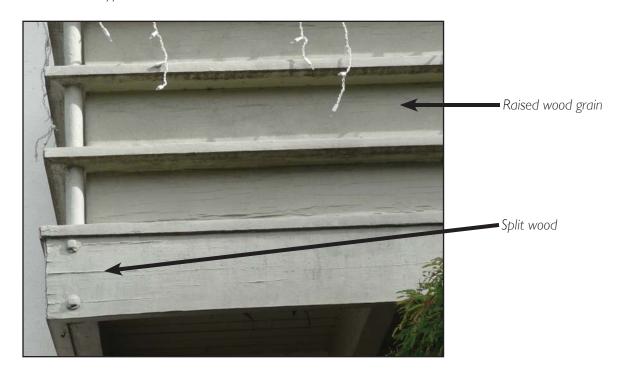
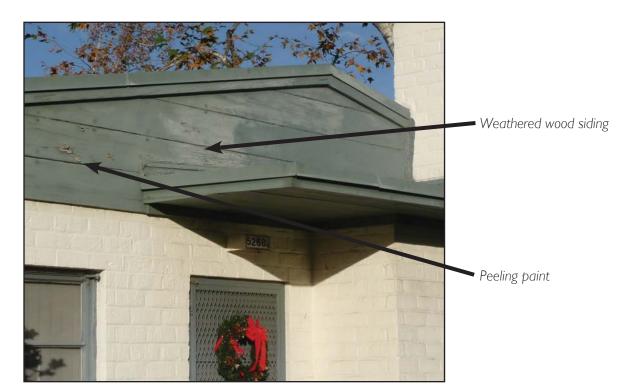
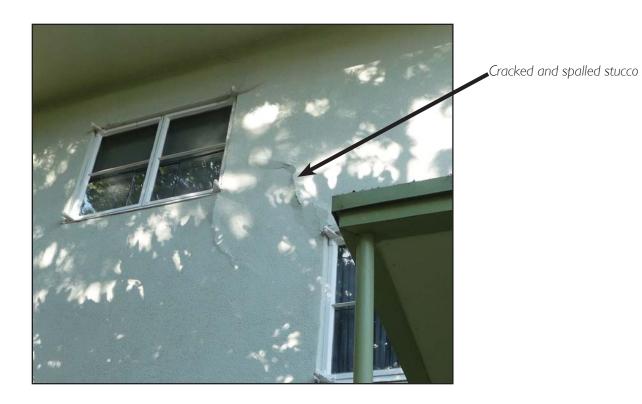
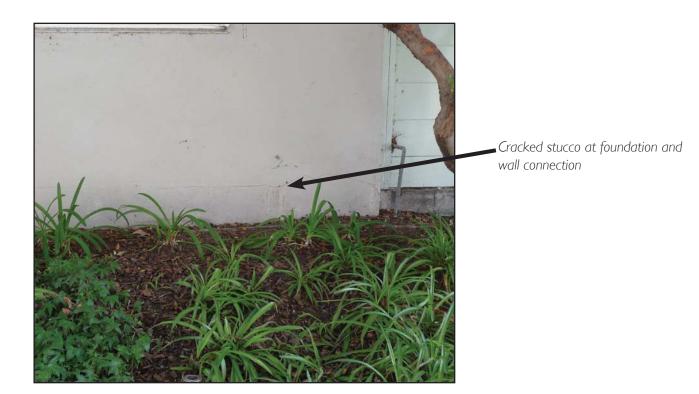
Walls and Siding Conditions

Wall and siding conditions vary greatly depending on the material used and its location. Typical conditions include:

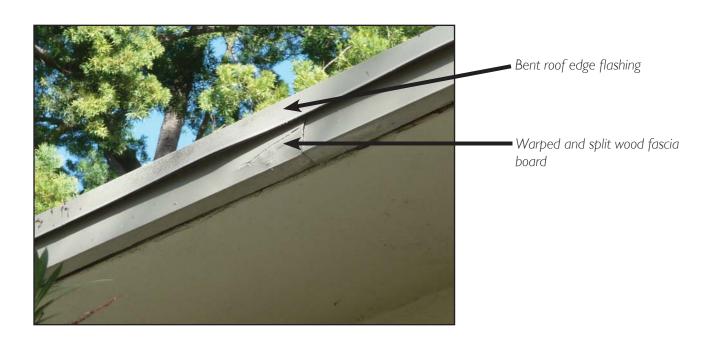
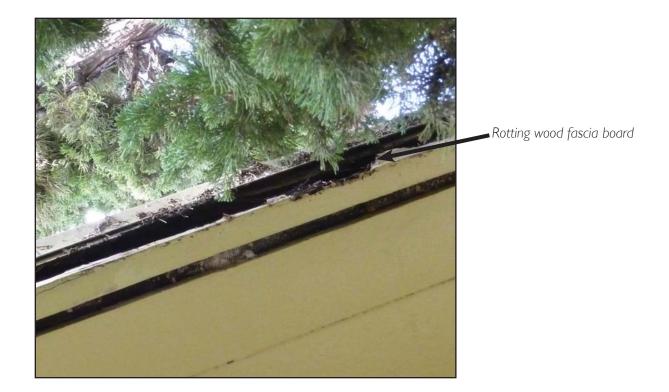
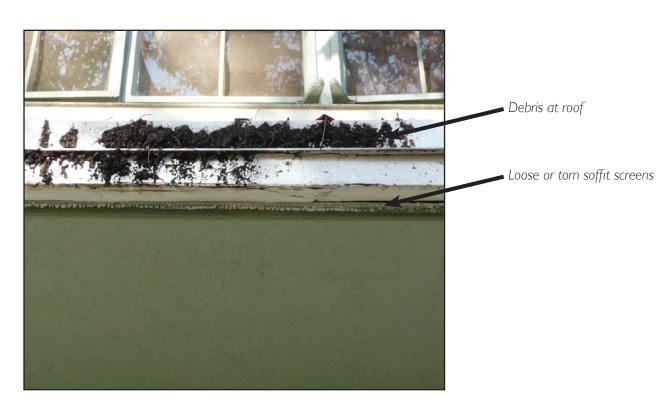
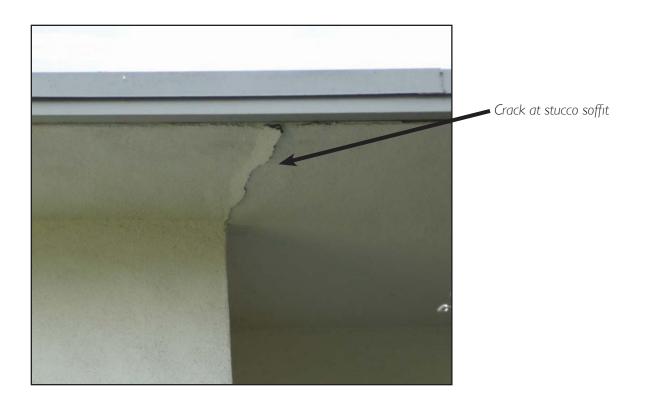
Roofing Conditions

In general, roofing systems are in good condition. Most roofing deficiencies noted are related to deterioration at the fascia or soffit. Typical conditions include:

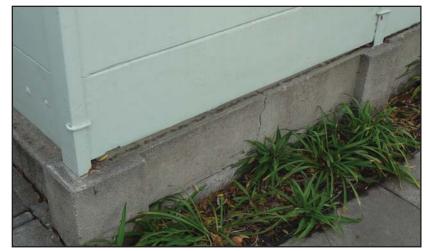
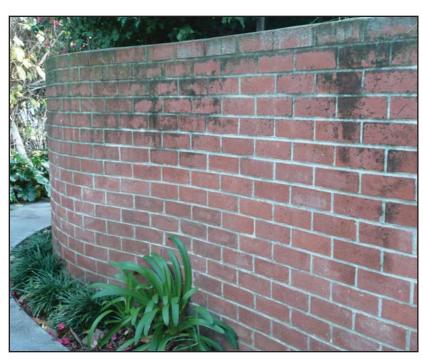
Good Condition

Patio walls in good condition typically exhibit only minor cracking at brick patio walls, and limited deterioration of wood dividing walls, such as small areas of peeling paint or only small foundation cracks. Deficiencies can be easily repaired.

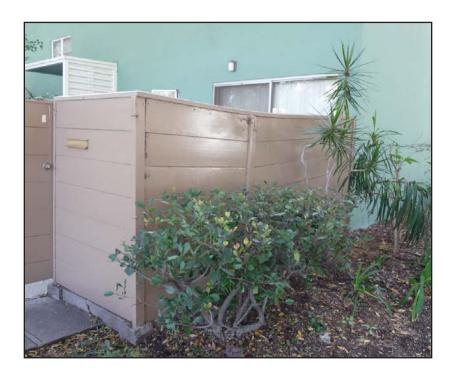
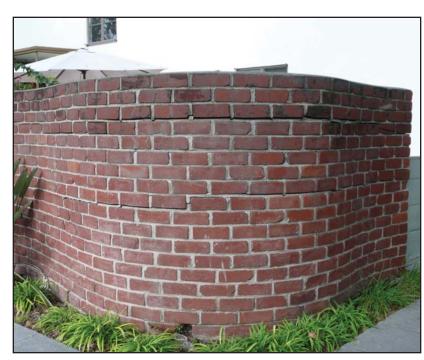
Fair Condition

Patio walls in fair condition have moderate cracking at brick patio walls, small areas of rot, peeling paint, or other deterioration at wood divider walls, and minor cracking or settlement at concrete foundations below wood divider walls. Deficiencies are serious, but can be repaired.

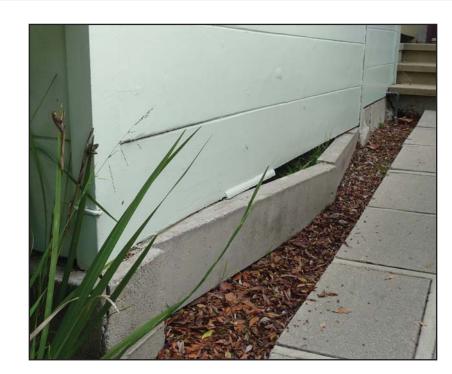
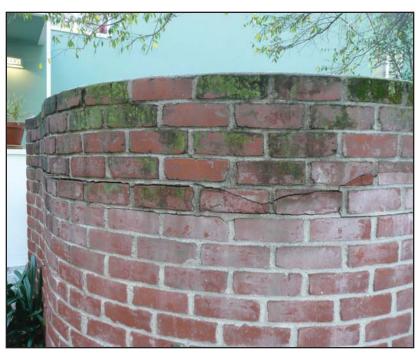
Poor Condition

Patio walls in poor condition typically have serious cracking or spalling at brick patio walls, large areas of rot, peeling paint, or other deterioration at wood divider walls, and serious cracking, displacement, or settlement of concrete foundations below wood divider walls. Deficiencies are serious, and will require extensive repairs or possible rebuilding of the patio walls.
