# MANAGER REPORT

## SEWERS 2011

The VGOA is responsible for approximately 4.3 miles of sewer lines.

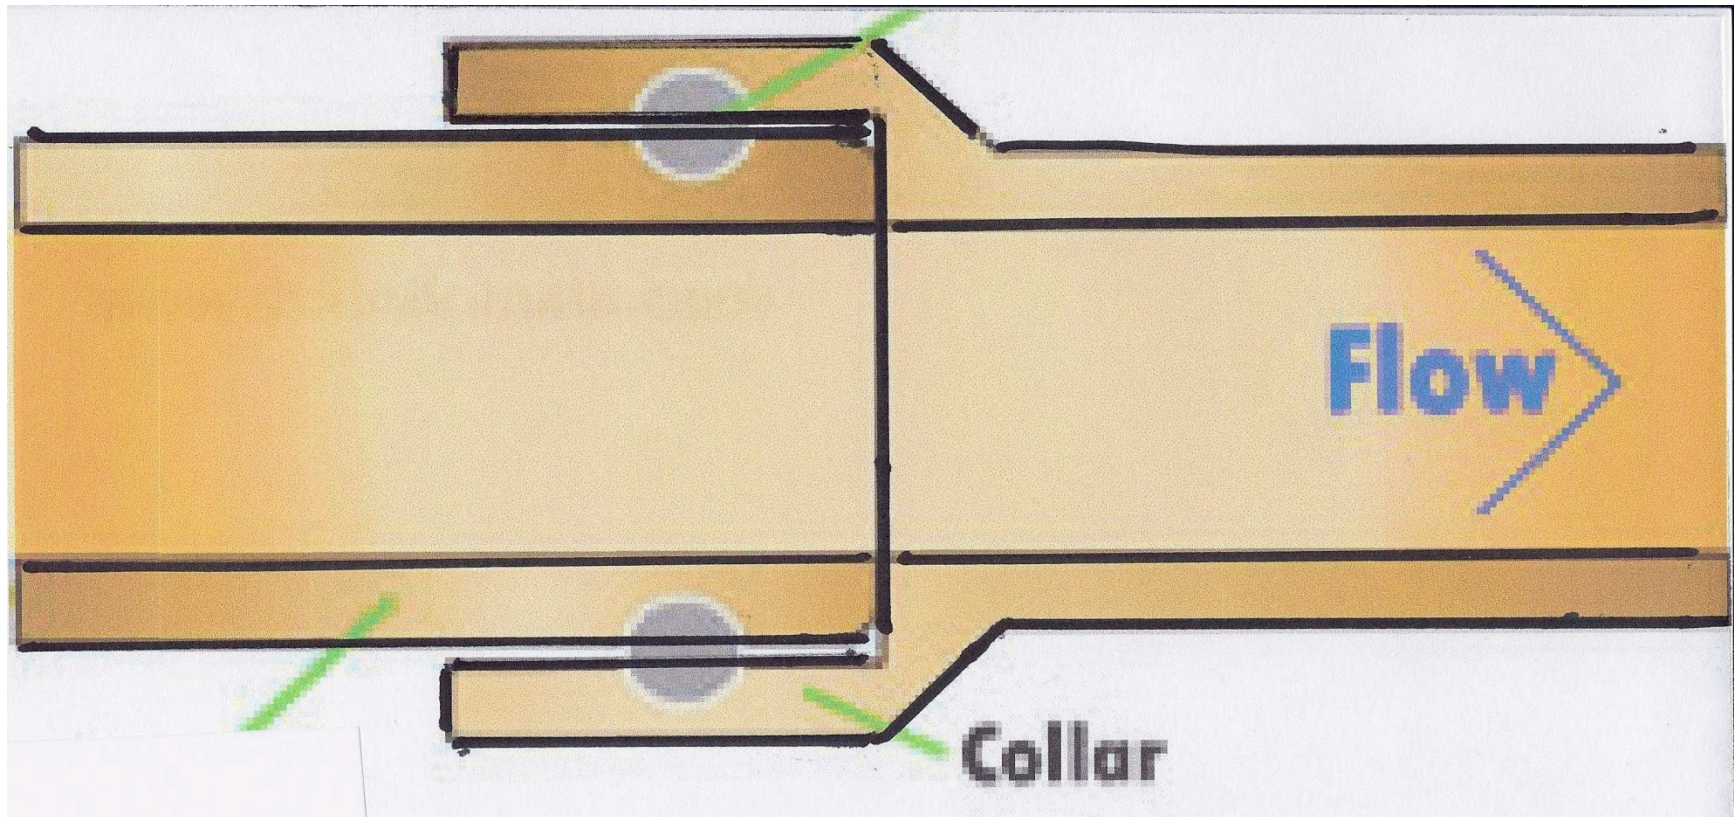
New Clay pipe connections are tight and the pipe is undamaged.

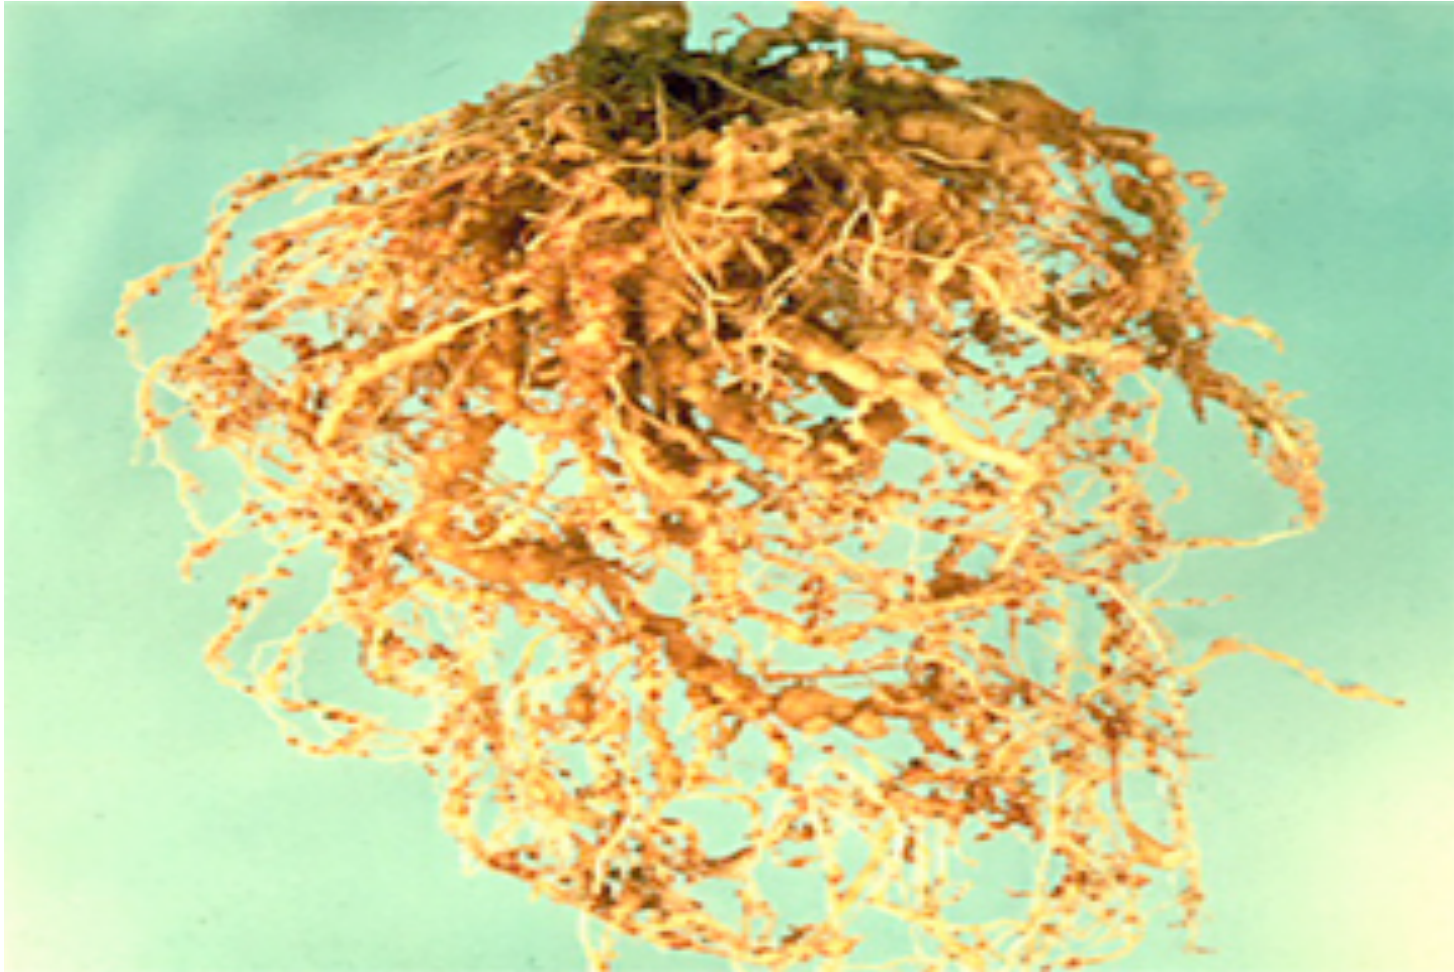
Roots are the primary enemy of sewer lines.

Roots find their way into the smallest cracks in pipes; once in, they grow very rapidly and clog the pipes.

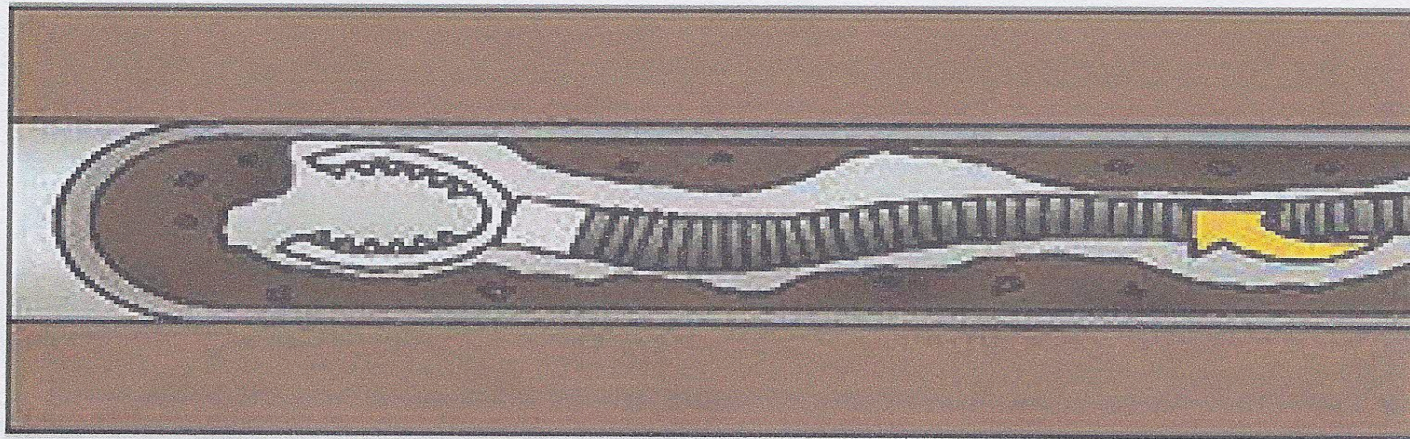
Opening with cable

**Cleaning the Lines is a temporary cure to a blockage problem and does not address the cause of the problem.**

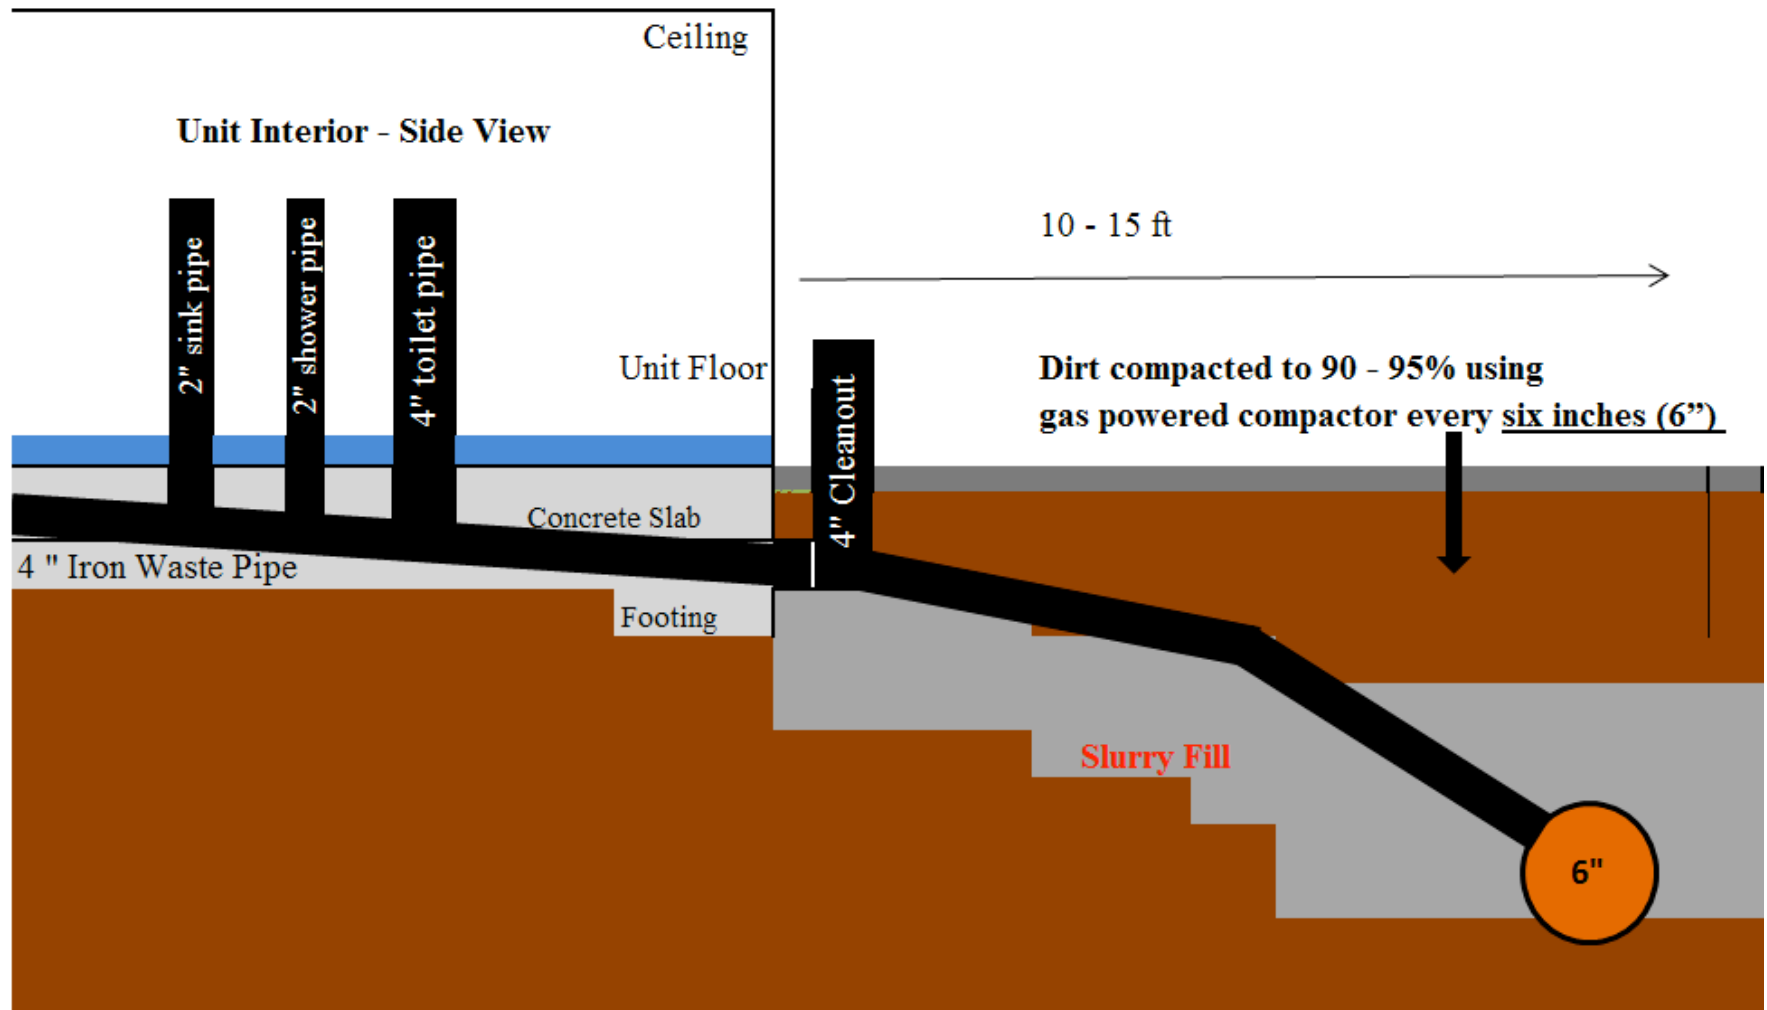
## Properly backfilled typical Lateral line.

**Improper backfilling will result in unstable soil conditions which will allow for sinking patios, fences, and perhaps buildings. It costs more to repair than to do properly the first time!**

- **Backfilling all holes and trenches using gas powered compactor every six inches (6") to achieve between 90% to 95% compaction.**
- **Excavations at and below the building footings require additional compaction at trenches and excavations within 18" of a footing and all excavations need to be backfilled with slurry or lean concrete up to the bottom of the footing elevation. Compaction 95% with 6' lifts in areas covered by concrete or within patio and 90% in grass or planter areas away from the structures.**

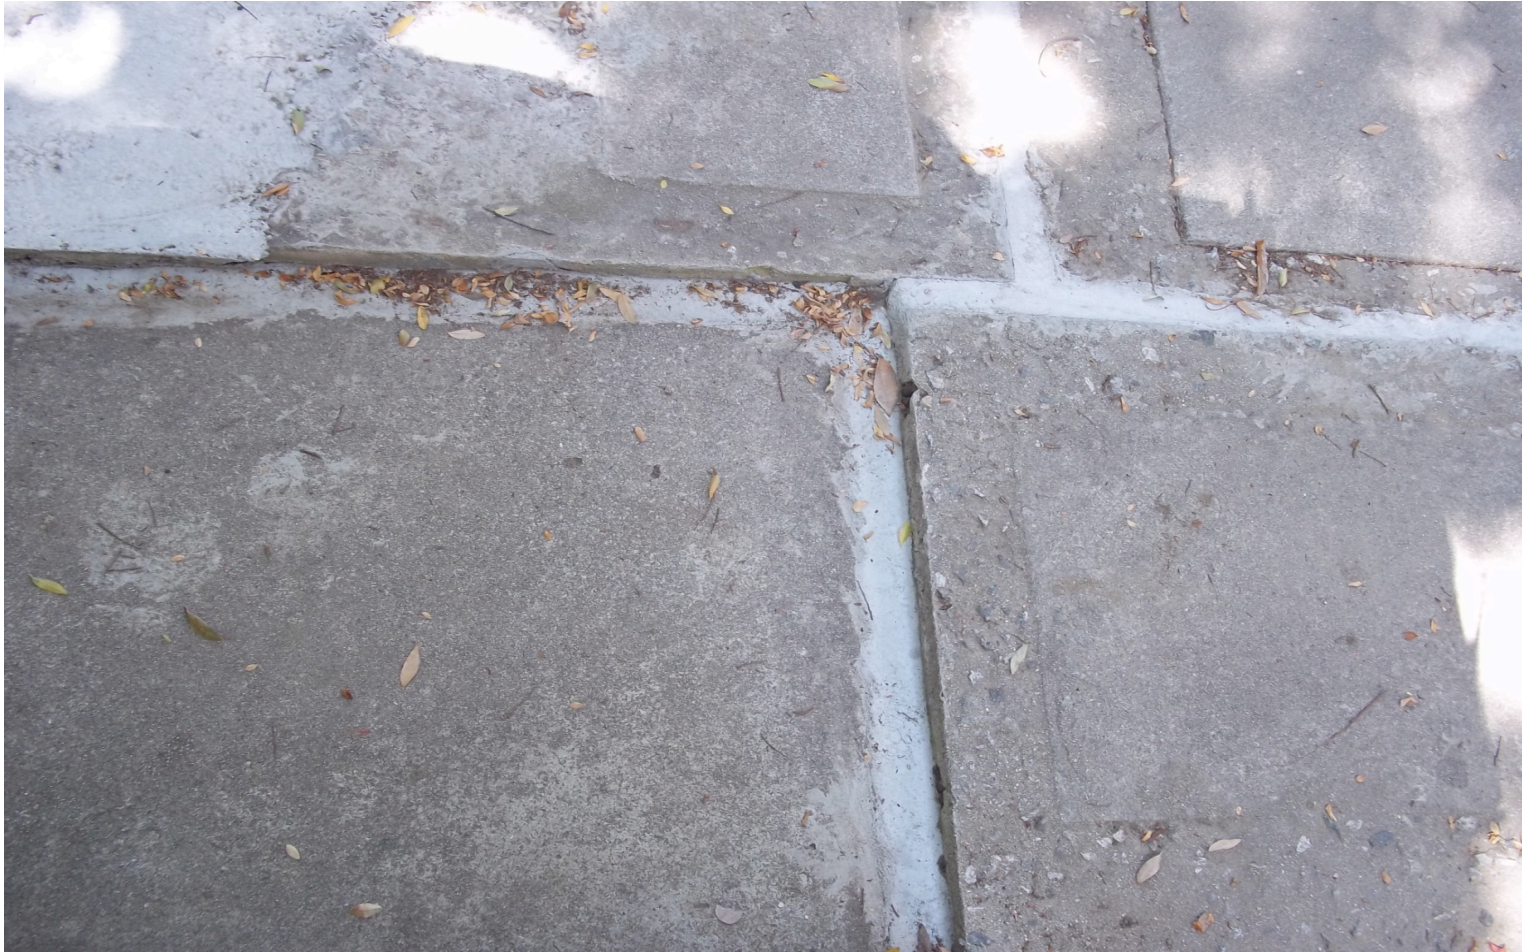
**Historically, patio repairs associated with sewer line work were minimal, and only made to the effected areas.**

**The work was done without proper techniques. Note the settling (sinking) of the paver in this photo.**

- The Board approved an allowance to repair/restore all patios to as good, or better, condition than when the work began.
- The repairs will be made to trip and fall hazard areas first, followed by cosmetic repairs.

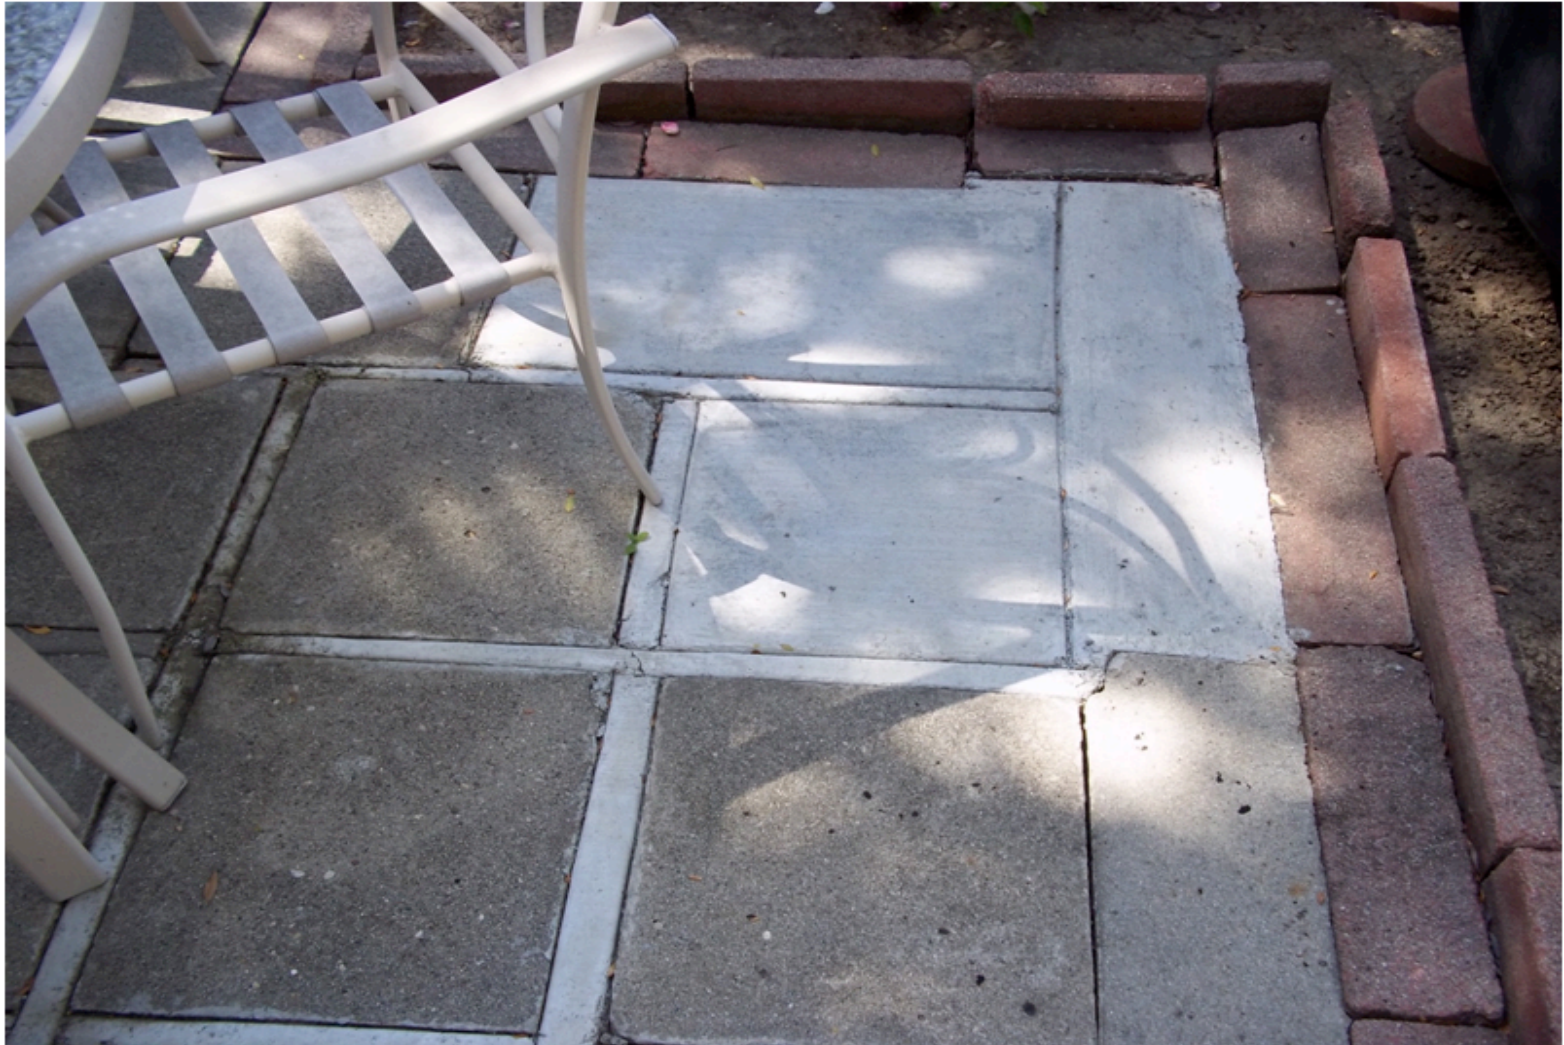
Additional example....

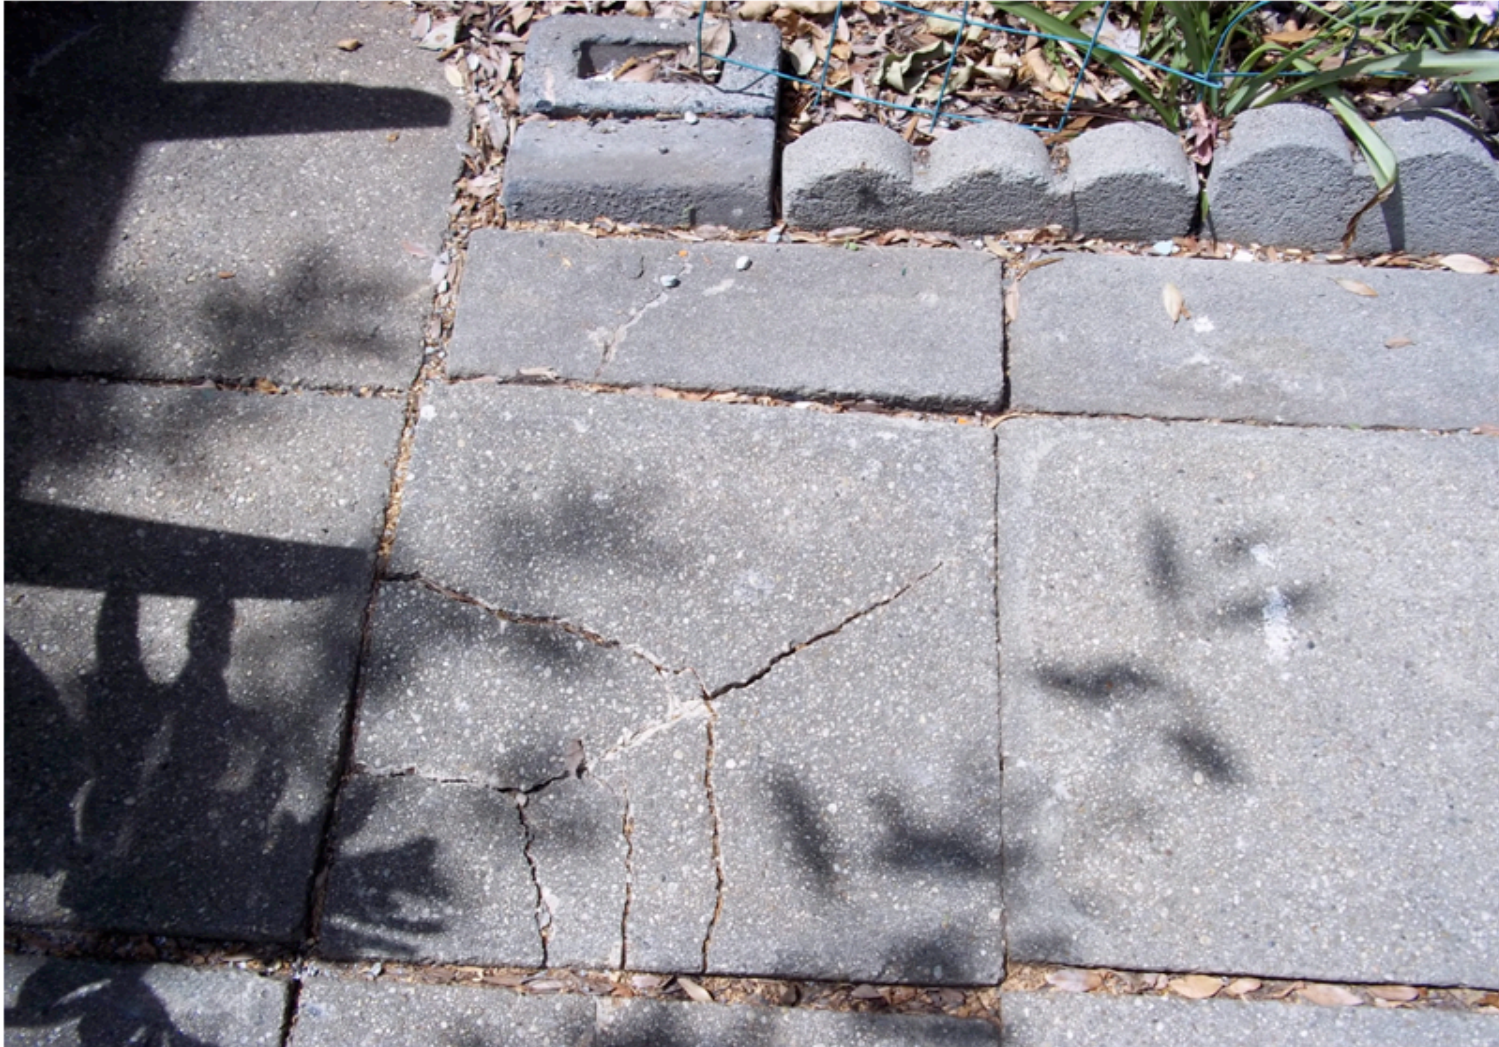
Also, no work was done to improve areas of the patios not effected by sewer work, although workers and material were there at the time to make efficient repairs.
